# Volume 3

# Facilities Assessment

CRAFTON HILLS COLLEGE MASTER PLAN  
SAN BERNARDINO COMMUNITY COLLEGE DISTRICT

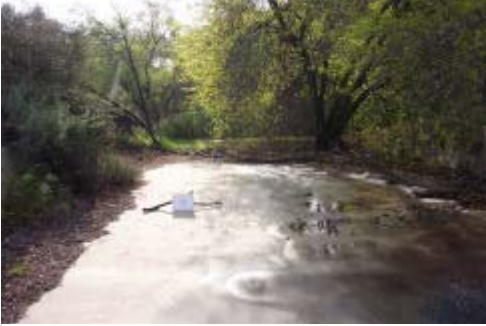
- Isolated areas adjacent to buildings that lack sufficient gradients to allow surface drainage to area drains or catch basins.
- Areas on concrete flatwork that lack sufficient gradient to direct surface drainage to catch basins.
- Catch basins and inlets appear to be in good condition and function adequately.
- Small diameter drains appear to function adequately.
- Large diameter storm drains appear to be well maintained and function properly.
- Channel located along the northerly side of Campus Drive has developed into a natural creek. The channel appears to have adequate capacity to convey site drainage. The channel requires annual maintenance to restrict growth of vegetation.
- Retention basin located in the vicinity of Campus Drive and Sand Canyon has filled with silt and is overgrown with vegetation.

Figure 4 – Retention basin spillway looking easterly into the basin.

- Add area drains and catch basin in landscape areas where surface drainage is poor and ponding occurs.
- Replace hardscape areas where ponding occurs.
- Remove vegetation and silt from the retention basin to allow the basin to function properly.

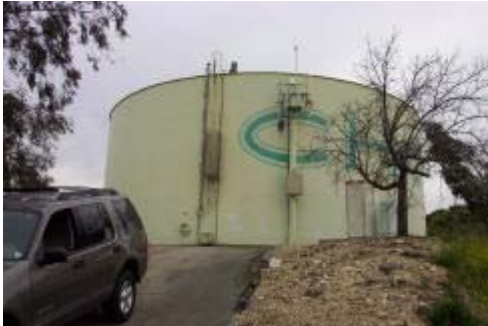
Figure 10 – Regulating reservoir located in the northeasterly portion of campus. Reservoir provides potable water to campus.

- The water distribution system must be upgraded to accommodate current requirements for fire flow.
- A detailed study of the current water distribution system will be prepared to determine the extent to which the system is deficient.
- Water main improvements will be required.

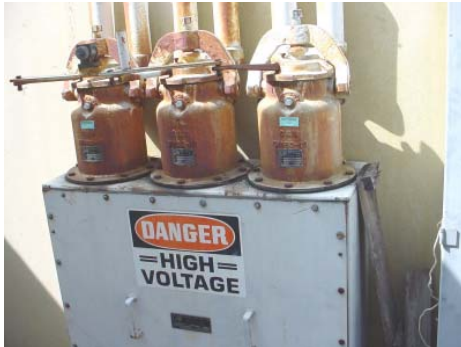
- The existing 5KV oil-filled fuse cut-outs are discontinued models from G&W and no replacement parts are available. These equipment are in excess of their life expectancy. At this time, these equipment are still in good working condition and there is no immediate need of replacement. However, if any of the building will require renovations, replacement of all existing electrical equipment is strongly recommended.

Figure 10 – Oil-filled fuse cut-outs.

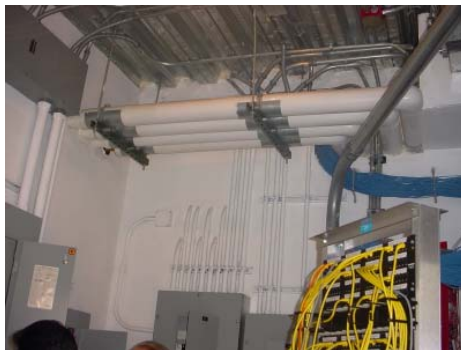
Figure 12 – HVAC pipes above electrical panel.

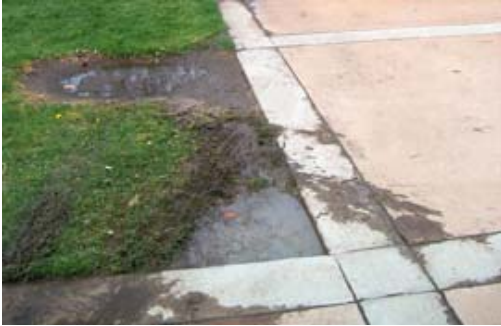
**Figure 2.8:** View of damage to paving, planting and irrigation.

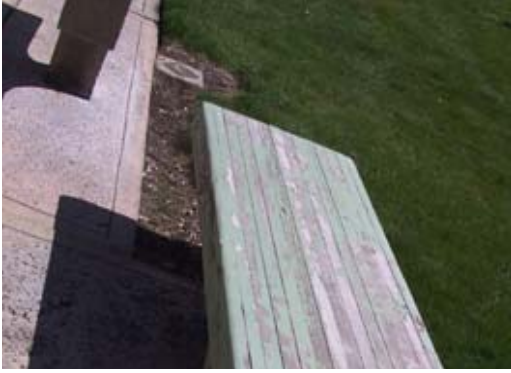
**Figure 6.4:** Paint and wood wear on many of the existing benches.

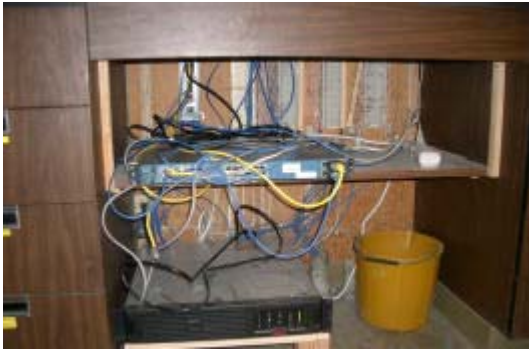
Figure 1 – View of communications equipment located in an exposed area beneath a credenza area of a classroom.

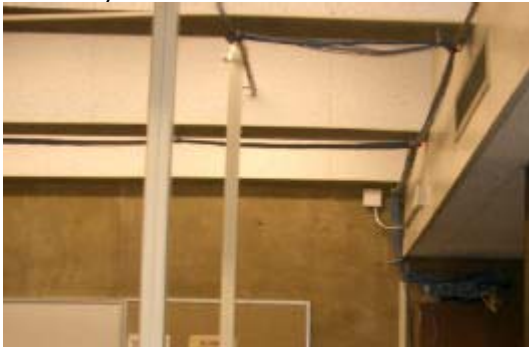
Figure 1 – Exposed cables are routed along walls and ceiling areas.

It is recommended that new riser and horizontal pathways be installed as part of existing building renovations. New pathways should be based on a District standard for distribution requirements.

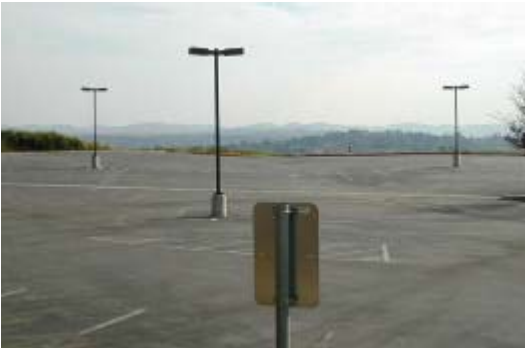
Figure 1.2 – Child Development parking – Low, sparse fixtures inadequate for area of parking lot.

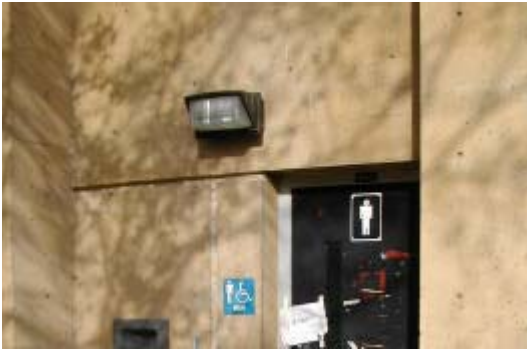
Figure 2.1 – Wall pack with prismatic refractor – visible lamp partially blinds pedestrians.

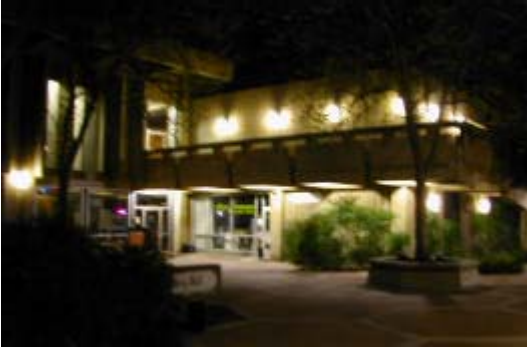
Figure 4.1 – Sconces scatter light, including upon buildings across courtyards.

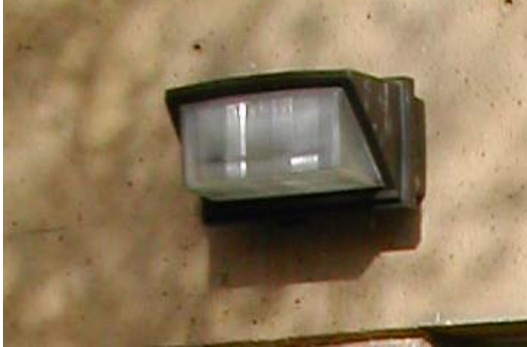
Figure 8.1 – Wall pack with prismatic refractor – Light is distributed up as well as down.

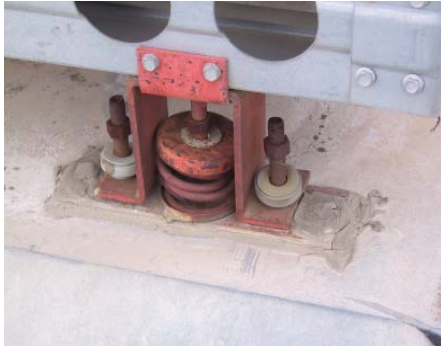
**Figure 1** – Example of vibration isolators that are shot and need to be replaced.

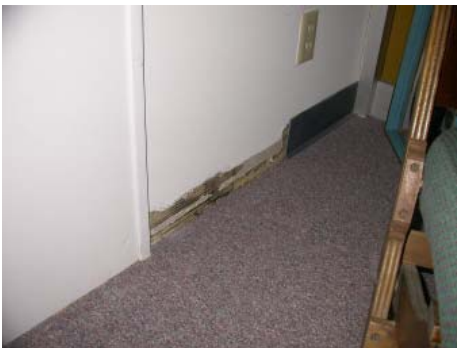
Damage to wall base.

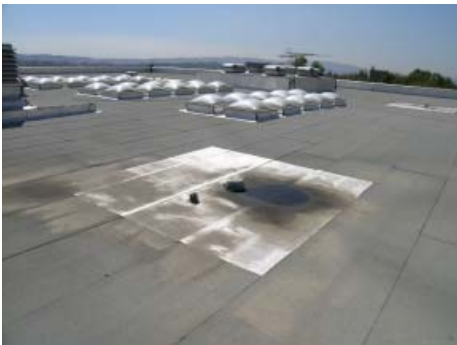
LRC/Library roof - Minor ponding at the library.

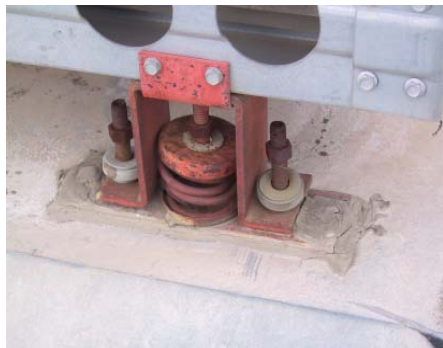
**Figure 1** – Example of vibration isolators that are shot and need to be replaced.

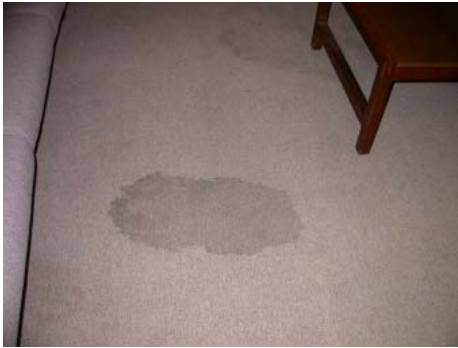
**Crafton Center** - Carpet stain.

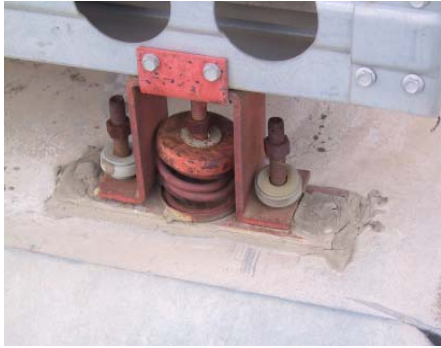
**Figure 1** – Example of vibration isolators that are shot and need to be replaced.

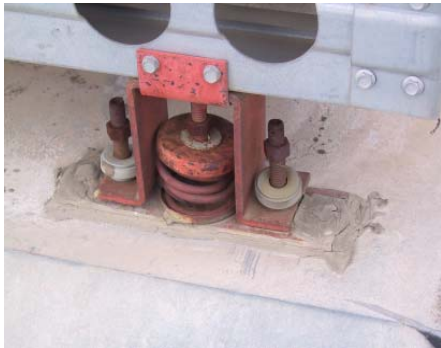
**Figure 1** – Example of vibration isolators that are shot and need to be replaced.

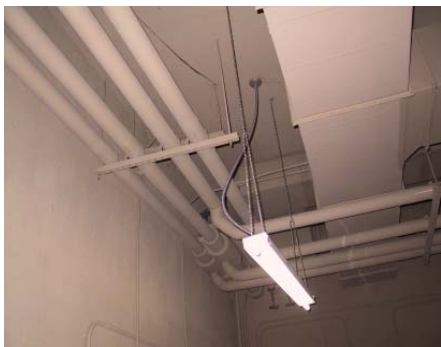
**Figure 2** – Example of no seismic bracing on the piping or the duct work.

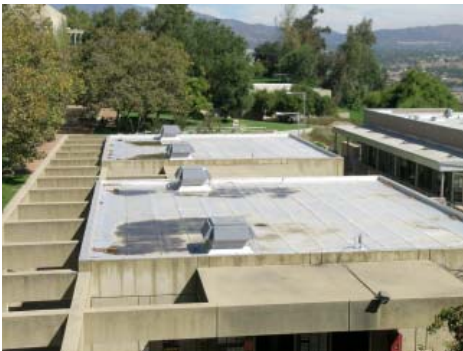
**Classroom Building** - Signs of ponding.

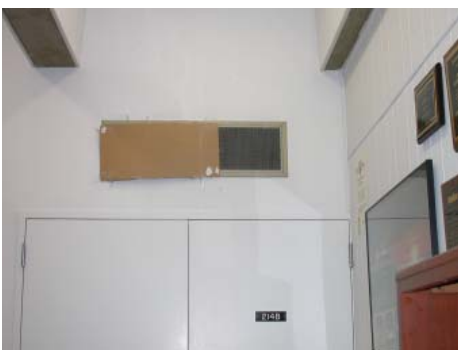
**Supply air register** - Occupants have partially blocked register as a means of controlling air flow.

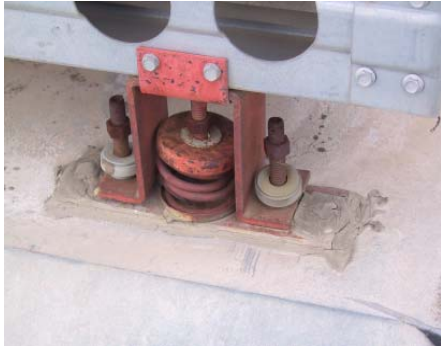
**Figure 1** – Example of vibration isolators that are shot and need to be replaced.

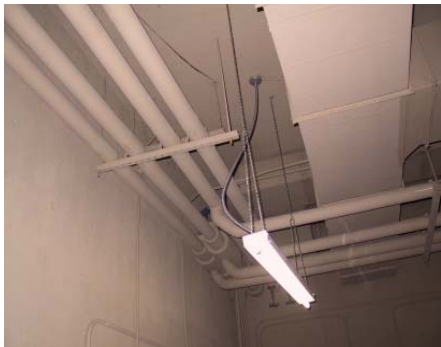
**Figure 2** – Example of no seismic bracing on the piping or the duct work.
