RE: SWACC PROPERTY & LIABILITY INSPECTION

SWACC PROPERTY & LIABILITY INSPECTION

January 2020

SAN BERNARDINO COMMUNITY COLLEGE DISTRICT

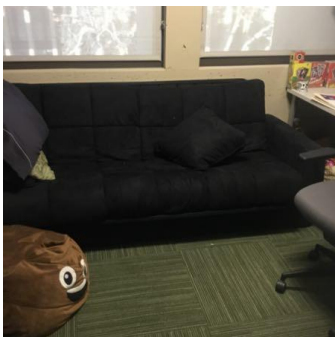
Description: Furniture like couches should be removed to help prevent any illicit incidents from occurring. Additionally, upholstered furniture must have a label stating the product meets the state flammability standard, Technical Bulletin 117, that requires filling materials inside the product to be flame and smolder-resistant.

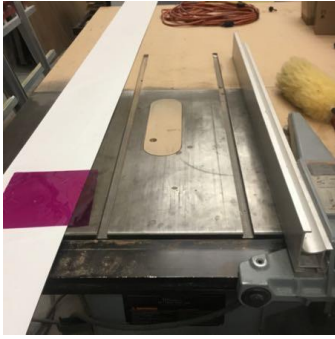
Description: Saws with missing or damaged protective guards should be removed from service immediately until repaired or replaced.

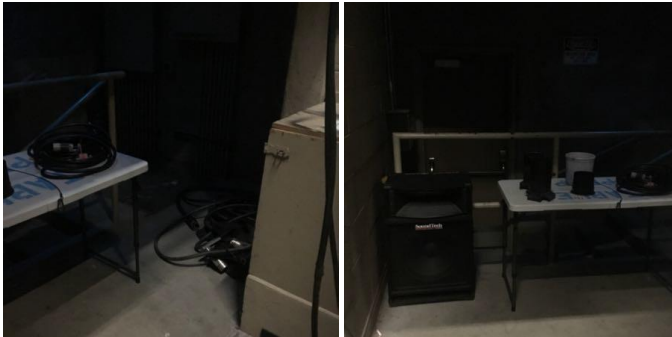
Description: Aisles and passageways were obstructed which could impede emergency egress. Aisles and passageways should be kept clear at all times and have a minimum width of 30 inches.

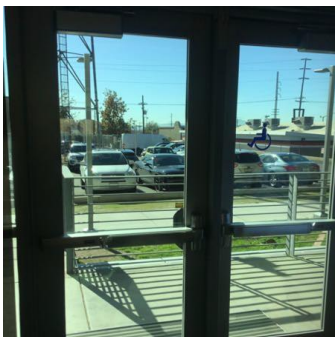
Description: The inoperable panic hardware device should be repaired or replaced to ensure safe egress in an emergency.

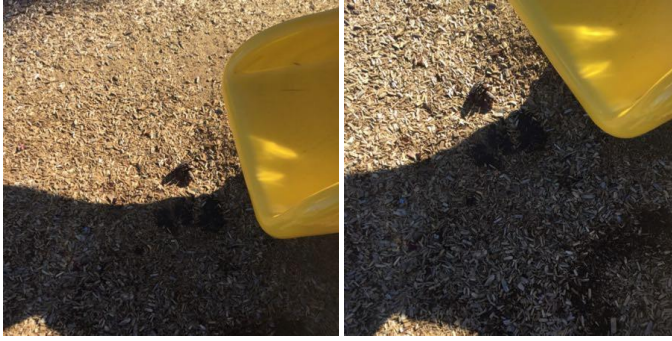
Location: San Bernardino Community College - SAN BERNARDINO VALLEY COLLEGE - Gym Weight Room 101

Description: Broken down, compacted or displaced loose fill surfacing material presents an elevated risk of head impact injuries. Adequate loose fill surfacing material depth should be determined based on the fall height of adjacent play equipment. Surfacing material should be added or re-distributed in this area to improve conditions and reduce this risk of head impact injuries.

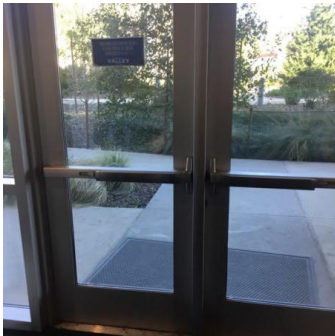
Description: There were defective exit door(s) that require excessive force to open, or that do not function properly. Defective door(s) should be repaired immediately to ensure proper egress. Cannot get in or out

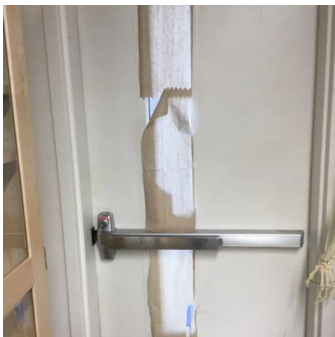
Description: In an effort to avoid sexual assault/molestation concerns, office windows should not be obstructed with paper or other material. Blinds or window coverings should be open while students are present, especially during one-on-one staff-student interaction. Office doors should remain open as well.

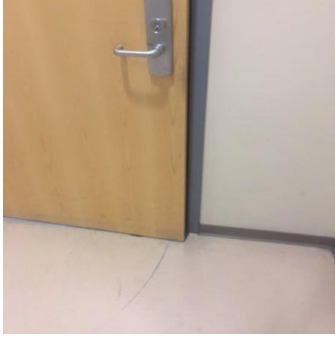
Description: The classroom had a defective exit door that did not close. The defective door should be repaired immediately to ensure the classroom is secured.

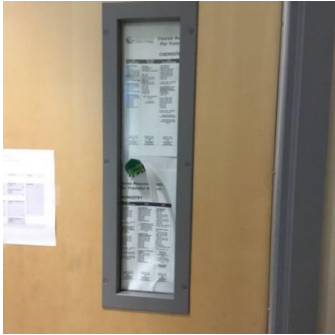
Description: In an effort to avoid sexual assault/molestation concerns, office windows should not be obstructed with paper or other material. Blinds or window coverings should be open while students are present, especially during one-on-one staff-student interaction. Office doors should remain open as well.

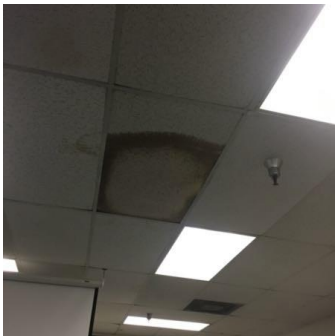
Description: Some of the ceiling tiles in this area are water-stained. The cause of the water stain should be identified and repairs should be made if necessary. The damaged tile should then be replaced.

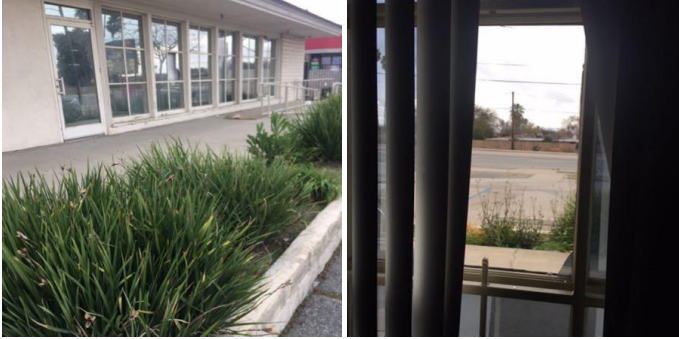
Location: San Bernardino Community College - 1888 E HIGHLAND AVE - Front Room

Description: The window in the front of the building was broken. The window should be repaired or replaced immediately to deter theft and unauthorized access.

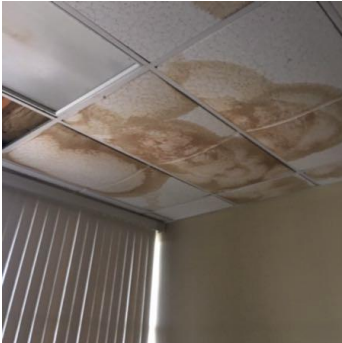
Location: San Bernardino Community College - 1888 E HIGHLAND AVE - Rooms

Description: Some of the ceiling tiles in this area are water-stained. The cause of the water stain should be identified and repairs should be made if necessary. The damaged tile should then be replaced.

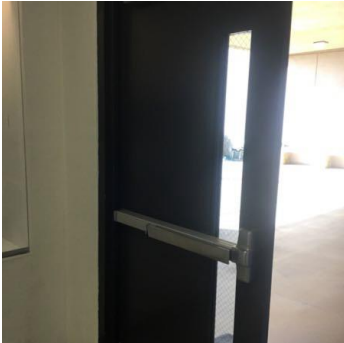
Location: San Bernardino Community College - CRAFTON HILLS COLLEGE - Central Complex Bldg
Lecture Hall Room 244

Description: The inoperable panic hardware device should be repaired or replaced to ensure safe egress in an emergency.

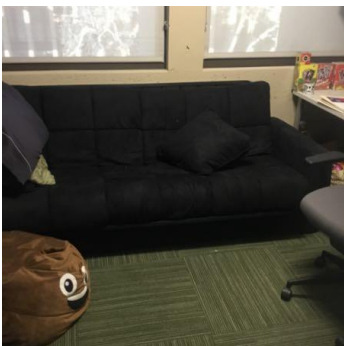
Description: Furniture like couches should be removed to help prevent any illicit incidents from occurring. Additionally, upholstered furniture must have a label stating the product meets the state flammability standard, Technical Bulletin 117, that requires filling materials inside the product to be flame and smolder-resistant.

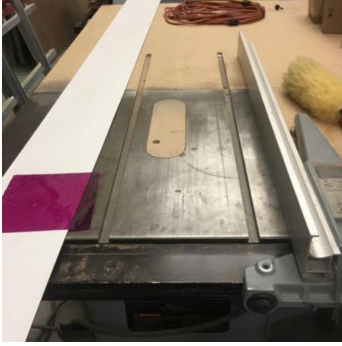
Location: San Bernardino Community College - CRAFTON HILLS COLLEGE - Finkelstein Performing Arts Center Theatre

Description: Saws with missing or damaged protective guards should be removed from service immediately until repaired or replaced.

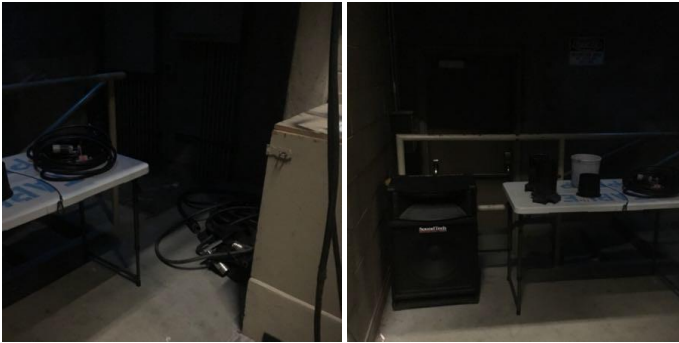
Description: Aisles and passageways were obstructed which could impede emergency egress. Aisles and passageways should be kept clear at all times and have a minimum width of 30 inches.

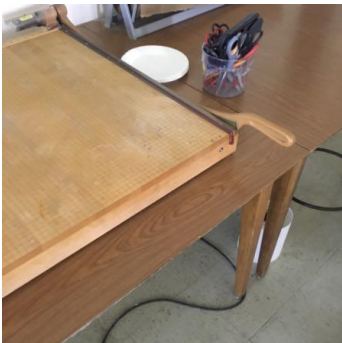
Location: San Bernardino Community College - CRAFTON HILLS COLLEGE - Art Bldg Hallway

Description: Guillotine-style paper cutters should be equipped with a blade guard, a blade lock, and a spring device to prevent the blade from free-falling. If any of these devices are missing or not functioning, the paper cutter should be removed until repaired or replaced.

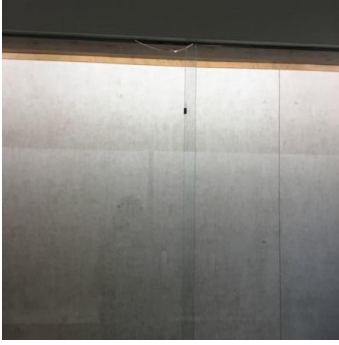
Location: San Bernardino Community College - CRAFTON HILLS COLLEGE - Campus Wide

Description: The glass with small chips or broken edges presents an elevated risk of laceration. Chipped or broken glass should be repaired or replaced to reduce associated risk.

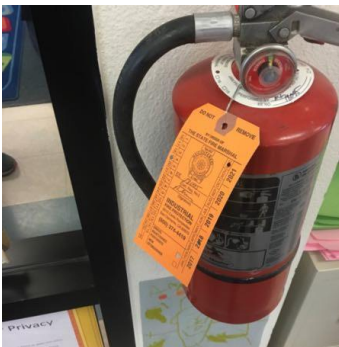
Location: San Bernardino Community College - CRAFTON HILLS COLLEGE - Central Complex Bldg CNTL 250

Description: The fire extinguisher was last serviced December 2018. The unit should be serviced to ensure a fully charged condition.

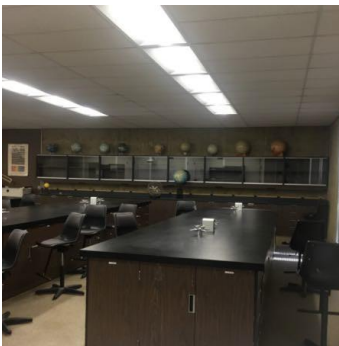
Location: San Bernardino Community College - CRAFTON HILLS COLLEGE - Child Development Center Bldg Hallway Between 126 & 123

Description: The heavy items stored on top of cabinets or overhead shelves present an elevated risk of struck by injuries. They can also block emergency egress if they fall to the floor. Heavy items should be stored at a lower level to reduce this hazard. Other items stored overhead should be secured in a manner that prevents them from falling.

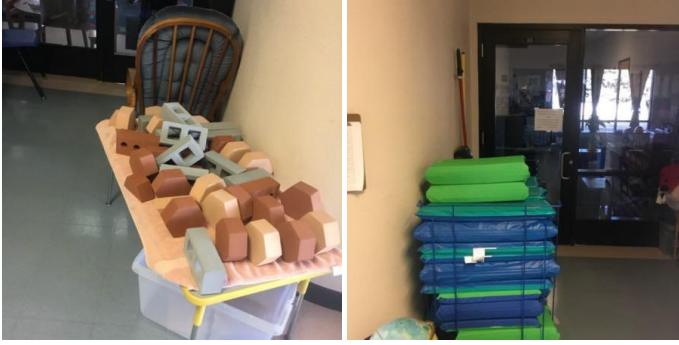
Description: Aisles and passageways were obstructed which could impede emergency egress. Aisles and passageways should be kept clear at all times and have a minimum width of 30 inches.

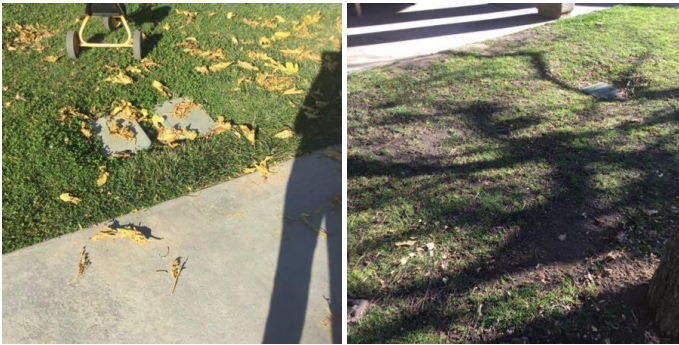
Location: San Bernardino Community College - CRAFTON HILLS COLLEGE - Child Development Center
Bldg Parking Lot

Description: Uneven field surfaces present a trip hazard and should be repaired.

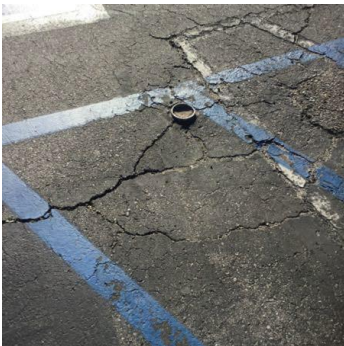
Location: San Bernardino Community College - CRAFTON HILLS COLLEGE - Child Development Center
Bldg Parking Lot

Description: The metal piece sticking up out of the ground presents a trip hazard and should be repaired to reduce this hazard.

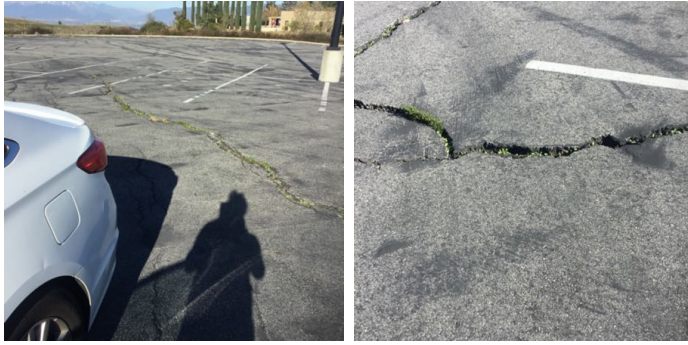
Location: San Bernardino Community College - CRAFTON HILLS COLLEGE - Child Development Center Bldg Playground

Description: Raised or cracked sections of asphalt/concrete present a trip hazard and should be repaired to reduce this hazard.

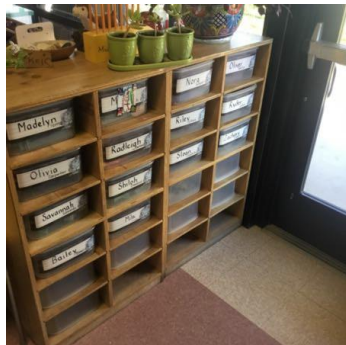
Location: San Bernardino Community College - CRAFTON HILLS COLLEGE - Child Development Center Bldg Room 123

Description: The unsecured bookcases and storage cabinets present an elevated risk of struck by injuries. They can also block emergency egress if they tip over. Bookcases and storage cabinets should be secured in a manner that prevents them from tipping over to reduce this hazard.

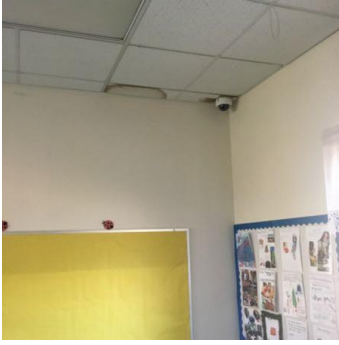
Location: San Bernardino Community College - CRAFTON HILLS COLLEGE - Child Development Center Bldg Room 126

Description: Some of the ceiling tiles in this area are water-stained. The cause of the water stain should be identified and repairs should be made if necessary. The damaged tile should then be replaced.

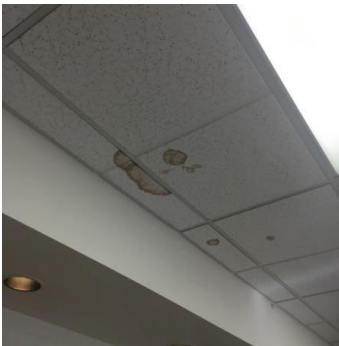
Location: San Bernardino Community College - CRAFTON HILLS COLLEGE - Child Development Center Bldg Room 2.2

Description: Some of the ceiling tiles in this area are water-stained. The cause of the water stain should be identified and repairs should be made if necessary. The damaged tile should then be replaced.

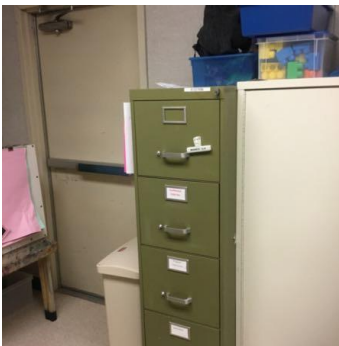
Location: San Bernardino Community College - CRAFTON HILLS COLLEGE - Clock Tower Bldg Office 320

Description: The unsecured bookcases and storage cabinets present an elevated risk of struck by injuries. They can also block emergency egress if they tip over. Bookcases and storage cabinets should be secured in a manner that prevents them from tipping over to reduce this hazard.

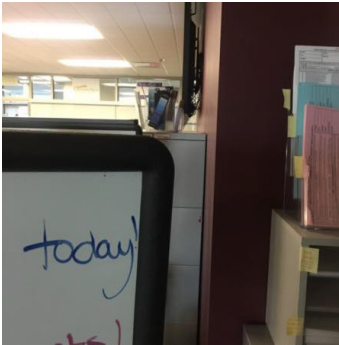
Location: San Bernardino Community College - CRAFTON HILLS COLLEGE - East Complex 2 BL 15 East 104

Description: The unsecured bookcases and storage cabinets present an elevated risk of struck by injuries. They can also block emergency egress if they tip over. Bookcases and storage cabinets should be secured in a manner that prevents them from tipping over to reduce this hazard.

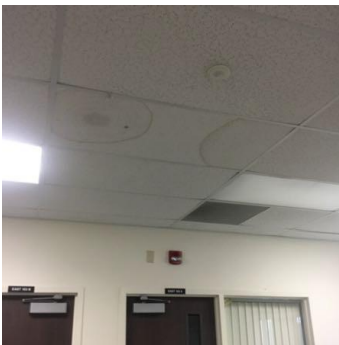
Location: San Bernardino Community College - CRAFTON HILLS COLLEGE - East Complex 2 BL 15 East 104

Description: Some of the ceiling tiles in this area are water-stained. The cause of the water stain should be identified and repairs should be made if necessary. The damaged tile should then be replaced.

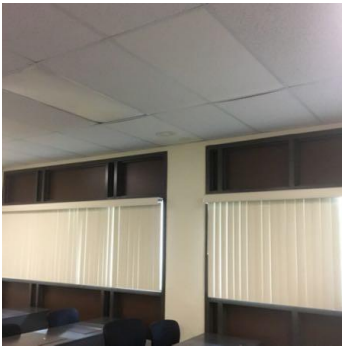
Location: San Bernardino Community College - CRAFTON HILLS COLLEGE - East Complex 2 East 103B

Description: Some of the ceiling tiles in this area are water-stained. The cause of the water stain should be

identified and repairs should be made if necessary. The damaged tile should then be replaced.

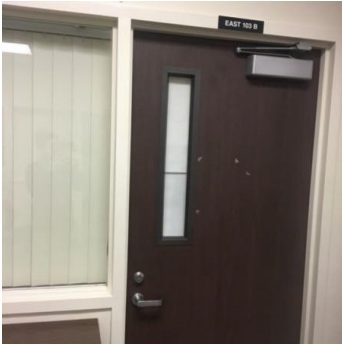
Description: In an effort to avoid sexual assault/molestation concerns, office windows should not be obstructed with paper or other material. Blinds or window coverings should be open while students are present, especially during one-on-one staff-student interaction. Office doors should remain open as well.

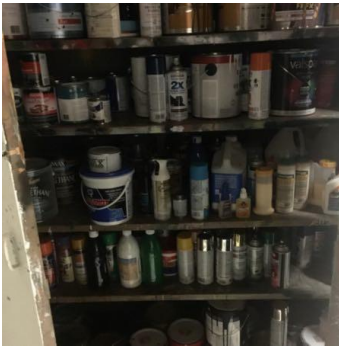
Description: An approved flammable liquid storage cabinet should be provided in this area.

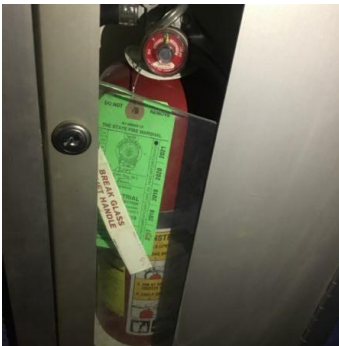
Location: San Bernardino Community College - CRAFTON HILLS COLLEGE - Finkelstein Performing Arts Center Theatre

Description: The fire extinguisher was last serviced December 2017. The unit should be serviced to ensure a fully charged condition.

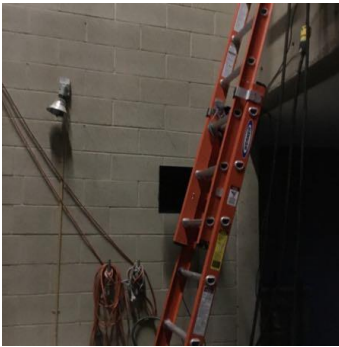
Description: Ladders should be stored secured in a manner that prevents tipping.

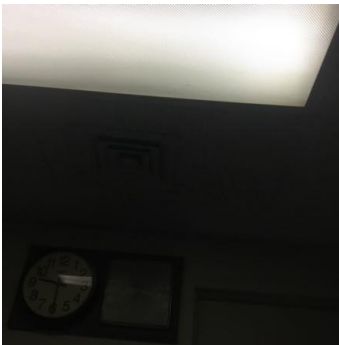
Location: San Bernardino Community College - CRAFTON HILLS COLLEGE - KHA Bldg Dance Studio Room 135

Description: Some of the ceiling tiles in this area are water-stained. The cause of the water stain should be identified and repairs should be made if necessary. The damaged tile should then be replaced.

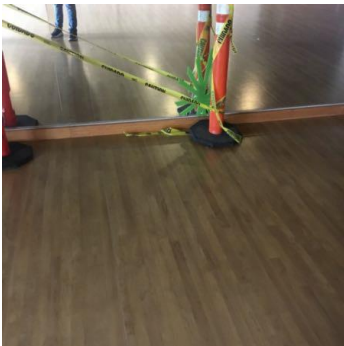
Description: Mirrors in yoga rooms should be coated with protective film designed to prevent shattering.

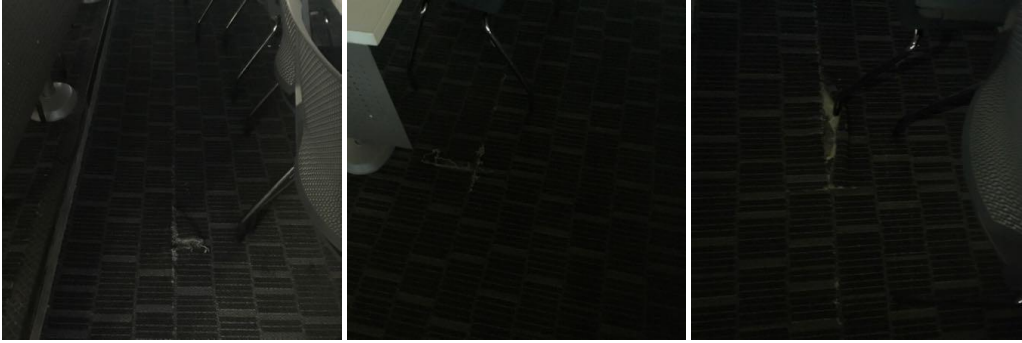
Location: San Bernardino Community College - CRAFTON HILLS COLLEGE - LRC BLDG Tutoring Center Annex

Description: Raised carpet in this area creates a trip hazard and should be repaired or replaced.

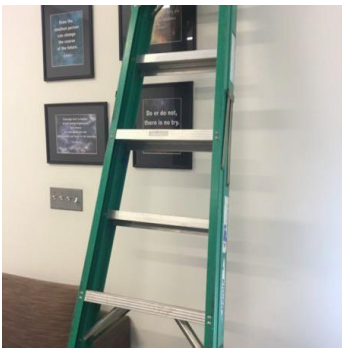
Description: Ladders should be stored secured in a manner that prevents tipping.

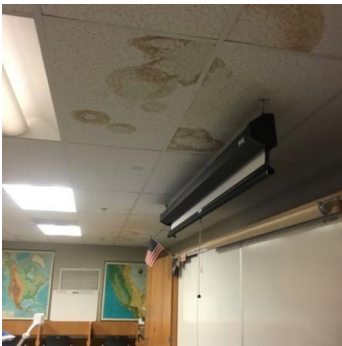
Location: San Bernardino Community College - CRAFTON HILLS COLLEGE - Outside Maintenance and Operations

Description: Some of the ceiling tiles in this area are water-stained. The cause of the water stain should be identified and repairs should be made if necessary. The damaged tile should then be replaced.

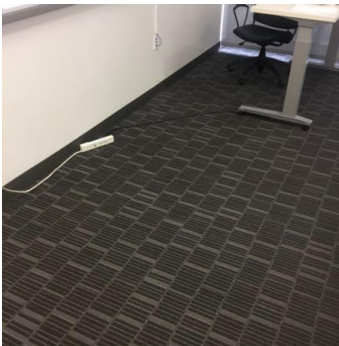
Location: San Bernardino Community College - CRAFTON HILLS COLLEGE - PSAH Bldg Study Lounge 217

Description: The cords on the floor creates a trip hazard in this area. The cords should be rerouted or covered with a cord cover/protector to reduce this hazard.

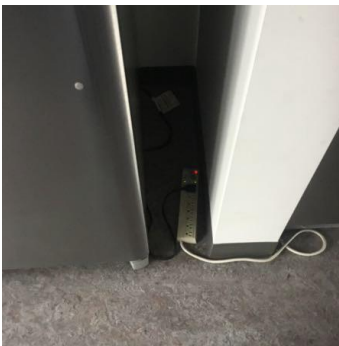
Location: San Bernardino Community College - CRAFTON HILLS COLLEGE - Soccer Fields

Description: The practice of plugging the refrigerator into a surge protector is not recommended. The appliances can overload the electrical circuit in the room and present an increased fire hazard. The refrigerator should be plugged directly into the electrical outlet.

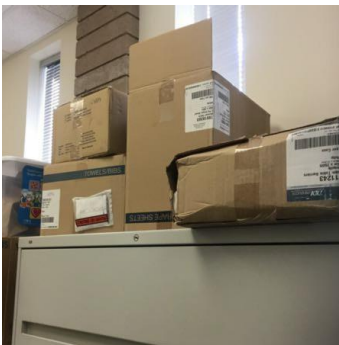
Description: The heavy items stored on top of cabinets or overhead shelves present an elevated risk of struck by injuries. They can also block emergency egress if they fall to the floor. Heavy items should be stored at a lower level to reduce this hazard. Other items stored overhead should be secured in a manner that prevents them from falling.

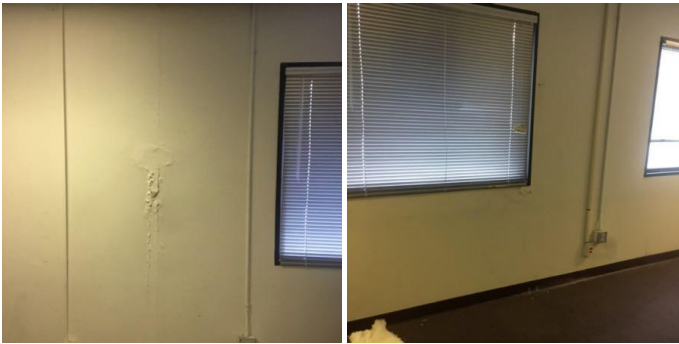
Description: The wall appears to have water damage the source of the leak should be found and repaired to mitigate the water damage hazard that was observed.

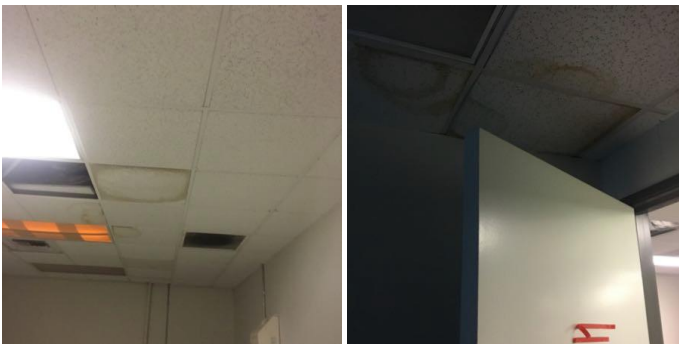
Description: Some of the ceiling tiles in this area are water-stained. The cause of the water stain should be identified and repairs should be made if necessary. The damaged tile should then be replaced.

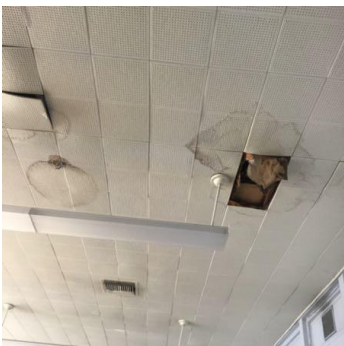
Description: Some of the ceiling tiles in this area are water-stained. The cause of the water stain should be identified and repairs should be made if necessary. The damaged tile should then be replaced.

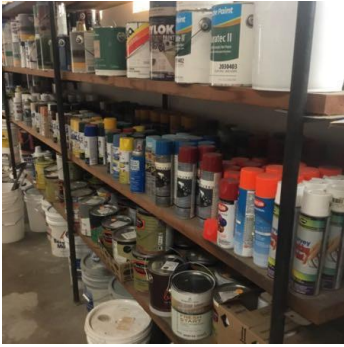
Description: An approved flammable liquid storage cabinet should be provided in this area.

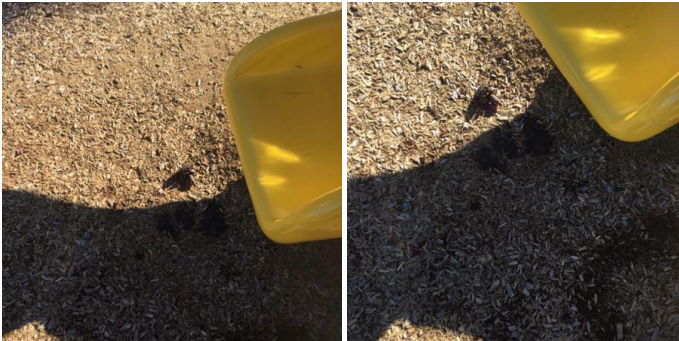
Description: Broken down, compacted or displaced loose fill surfacing material presents an elevated risk of head impact injuries. Adequate loose fill surfacing material depth should be determined based on the fall height of adjacent play equipment. Surfacing material should be added or re-distributed in this area to improve conditions and reduce this risk of head impact injuries.

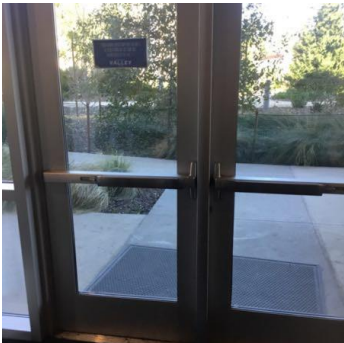
Description: There were defective exit door(s) that require excessive force to open, or that do not function properly. Defective door(s) should be repaired immediately to ensure proper egress. Cannot get in or out

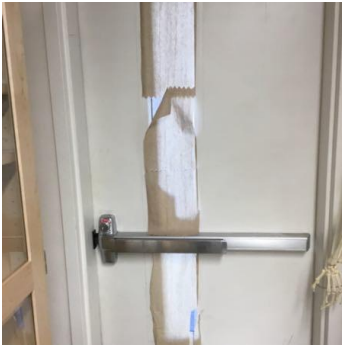
Description: In an effort to avoid sexual assault/molestation concerns, office windows should not be obstructed with paper or other material. Blinds or window coverings should be open while students are present, especially during one-on-one staff-student interaction. Office doors should remain open as well.

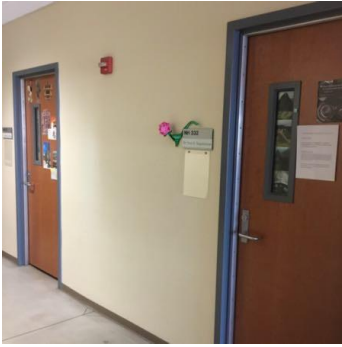
Description: In an effort to avoid sexual assault/molestation concerns, office windows should not be

obstructed with paper or other material. Blinds or window coverings should be open while students are present, especially during one-on-one staff-student interaction. Office doors should remain open as well.

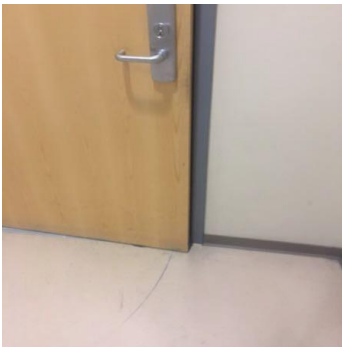
Description: The classroom had a defective exit door that did not close. The defective door should be repaired immediately to ensure the classroom is secured.

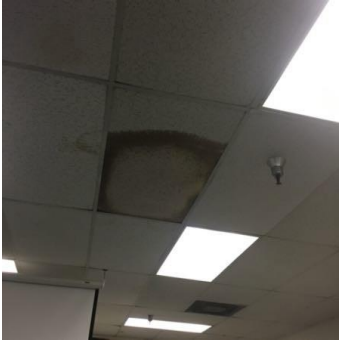
Description: Some of the ceiling tiles in this area are water-stained. The cause of the water stain should be identified and repairs should be made if necessary. The damaged tile should then be replaced.

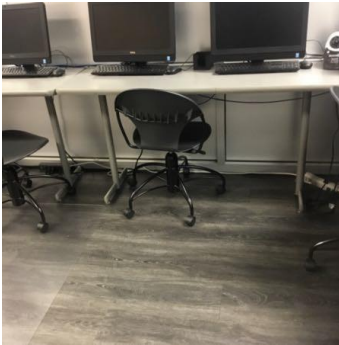
Description: Connecting extension cords and/or multi outlet power strips end-to-end presents an elevated risk of fire or circuit overload.

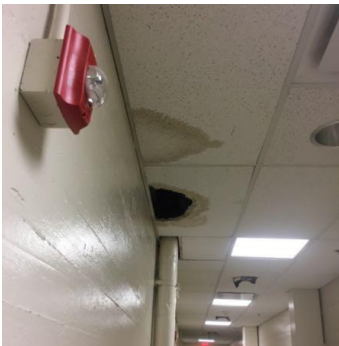
Description: Some of the ceiling tiles in this area are water-stained. The cause of the water stain should be identified and repairs should be made if necessary. The damaged tile should then be replaced.

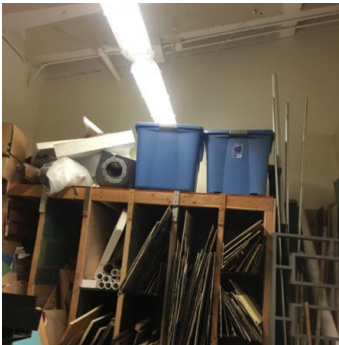
Description: The heavy items stored on top of cabinets or overhead shelves present an elevated risk of struck by injuries. They can also block emergency egress if they fall to the floor. Heavy items should be stored at a lower level to reduce this hazard. Other items stored overhead should be secured in a manner that prevents them from falling.

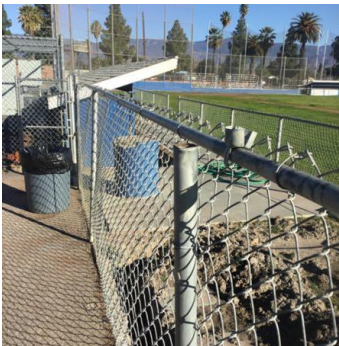
Description: Defective or damaged fencing can present a hazard for potential injury. Defective or damaged chain link fence should be repaired or replaced to reduce these hazards.

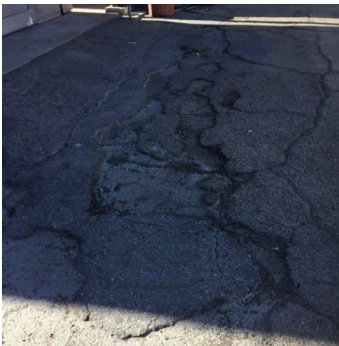
Description: Raised or cracked sections of asphalt/concrete present a trip hazard and should be repaired to reduce this hazard.

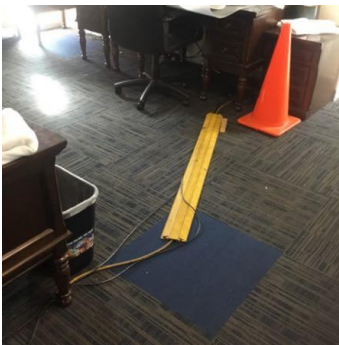
Description: Extension cords are not designed for permanent use. The extension cord should be replaced with permanent wiring in accordance with the National Electric Code.

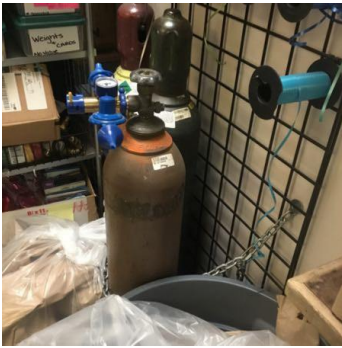
Description: Compressed gas cylinders should always be secured in a manner to keep them in the upright

position with very little room to move with a strong securing device such as a chain, strap or clamp.

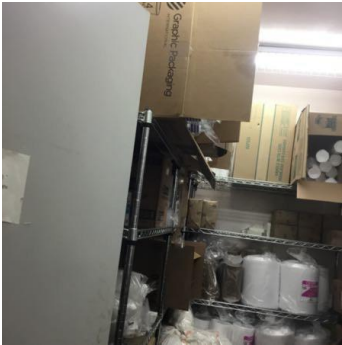
Description: The heavy items stored on top of cabinets or overhead shelves present an elevated risk of struck by injuries. They can also block emergency egress if they fall to the floor. Heavy items should be stored at a lower level to reduce this hazard. Other items stored overhead should be secured in a manner that prevents them from falling.

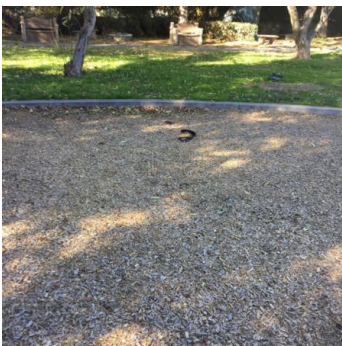
Description: Exposed weed barrier material presents an elevated trip hazard and should be covered or repaired to reduce this hazard.

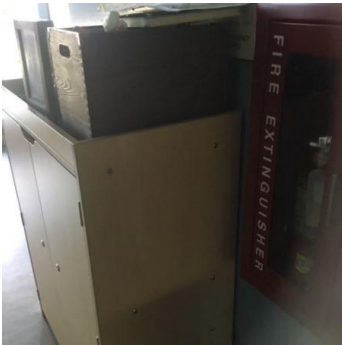
Description: The unsecured bookcases and storage cabinets present an elevated risk of struck by injuries. They can also block emergency egress if they tip over. Bookcases and storage cabinets should be secured in a manner that prevents them from tipping over to reduce this hazard.

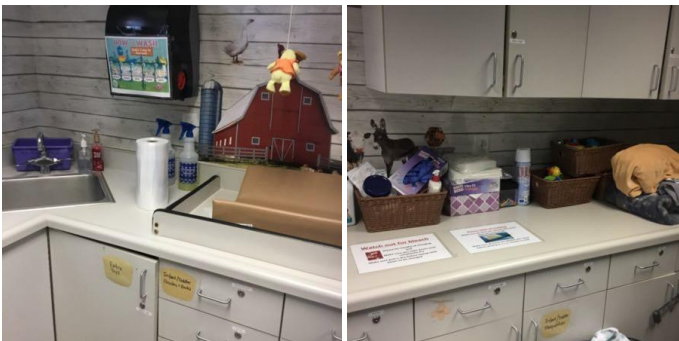
Description: Hazardous chemicals and cleaning products should not be stored in areas that are accessible to children. The chemicals were stored on the counter top by where they change the babies. Chemicals should be stored in an inaccessible area.

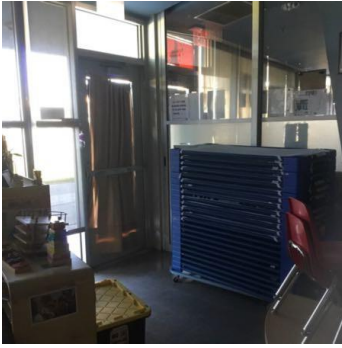
Description: Aisles and passageways were obstructed which could impede emergency egress. Aisles and

passageways should be kept clear at all times and have a minimum width of 30 inches.

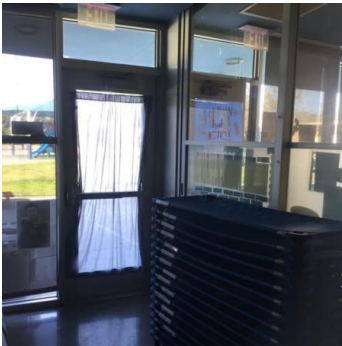
Description: Aisles and passageways were obstructed which could impede emergency egress. Aisles and passageways should be kept clear at all times and have a minimum width of 30 inches.

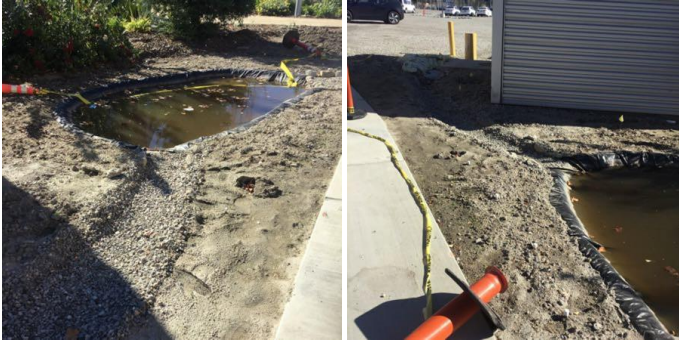
Description: Standing water presents an elevated slip hazard. Standing water can also become stagnate which presents elevated health hazards. Grading or drainage should be improved to reduce the hazards associated with standing water. Draining issue

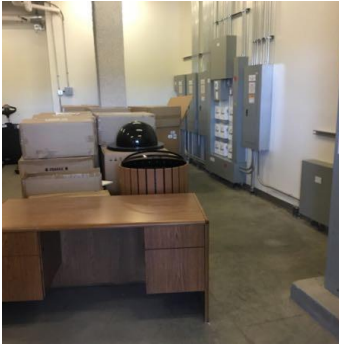
Description: A minimum 36" clearance zone should be maintained around the electrical panel(s) at all times. Excessive or improper storage of items near the electrical panel(s) may lead to inaccessibility, an increased risk of fire, and may impact the lifespan of the electrical equipment.

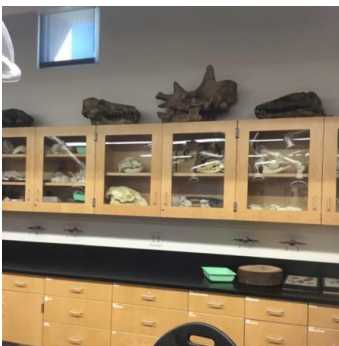
Description: The heavy items stored on top of cabinets or overhead shelves present an elevated risk of struck by injuries. They can also block emergency egress if they fall to the floor. Heavy items should be stored at a lower level to reduce this hazard. Other items stored overhead should be secured in a manner that prevents them from falling.

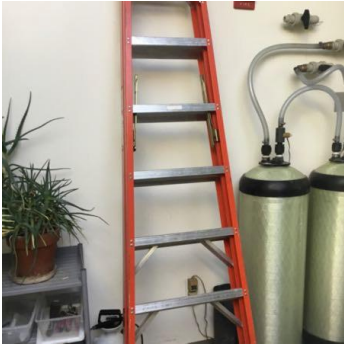
Description: Ladders should be stored secured in a manner that prevents tipping.

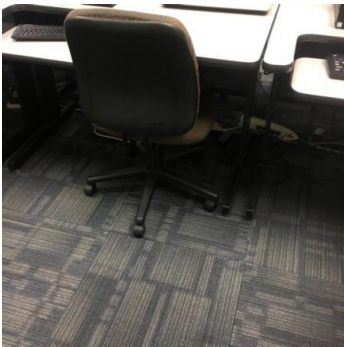
Description: Connecting extension cords and/or multi outlet power strips end-to-end presents an elevated risk of fire or circuit overload.

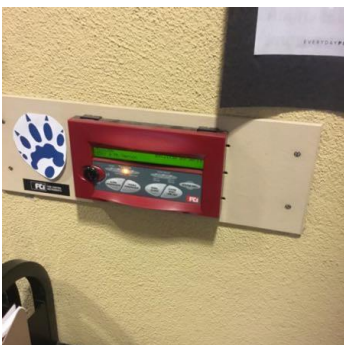
Description: The system trouble and/or system silence lights were lit on the main fire alarm panel. The fire alarm system should be operational at all times.

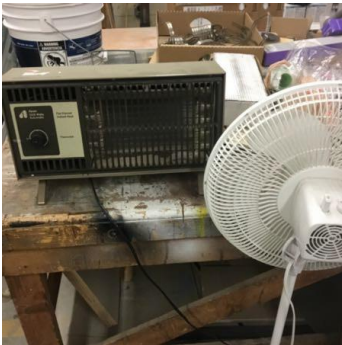
Description: Electric space heaters with exposed elements present an elevated risk of fire. Any electric space heater with exposed elements should be removed from the area. Electric liquid-filled radiator heaters with a UL rating are a lower-risk alternative to exposed element space heaters. However, no portable heater should be left on while unattended.

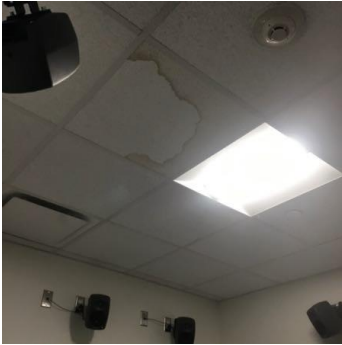
Description: Some of the ceiling tiles in this area are water-stained. The cause of the water stain should be identified and repairs should be made if necessary. The damaged tile should then be replaced.

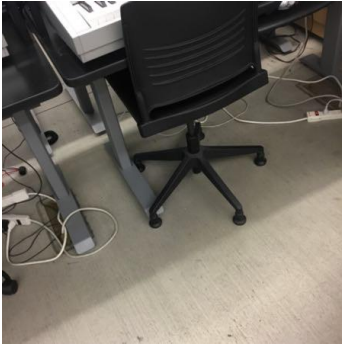
Description: Electrical cords on the floor creates a trip hazard in this area. The cords should be rerouted or covered with a cord cover/protector to reduce this hazard.

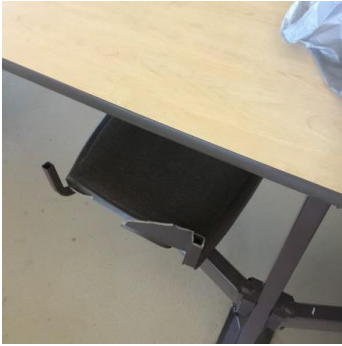
Description: The broken chair should be repaired or replaced to eliminate any potential hazards.

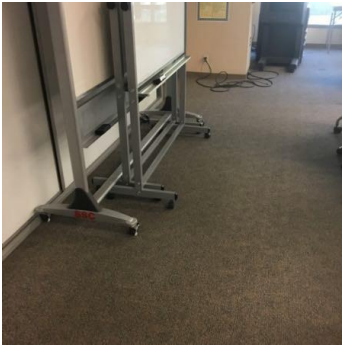
Description: Electrical cords on the floor creates a trip hazard in this area. The cords should be rerouted or covered with a cord cover/protector to reduce this hazard.

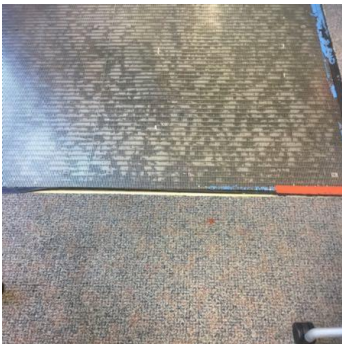
Description: The plastic transition was coming up creating a trip hazard. The plastic transition should be repaired or replaced to reduce this hazard.

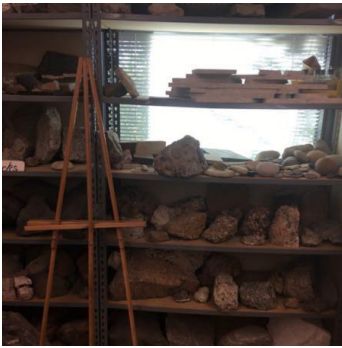
Description: Heavy items stored on top of cabinets or overhead shelves present an elevated risk of struck by injuries. They can also block emergency egress if they fall to the floor. Heavy items should be stored at a lower level to reduce this hazard. Other items stored overhead should be secured in a manner that prevents them

from falling.

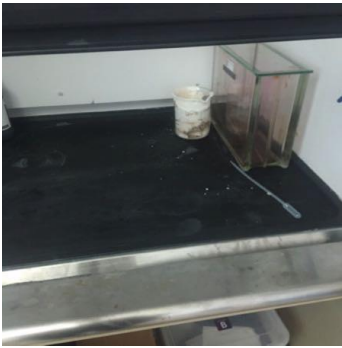
Description: 1. The container of chemicals was uncovered. The container should be provided with an appropriate cover or be replaced with a new container with closure. The contents should be kept safely covered or be properly disposed. 2. The contents of the unlabeled container(s) should be determined and the container(s) properly labeled. Labeling should include substance name, major hazard, precautionary statements, the name and address of the manufacturer or supplier, a harmonized signal word and pictogram.

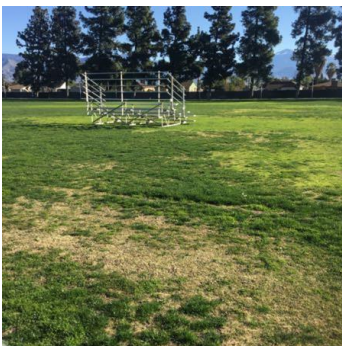
Description: Deteriorating seats or other degraded components on bleachers should be repaired or replaced according to manufacturer guidelines and recommendations.

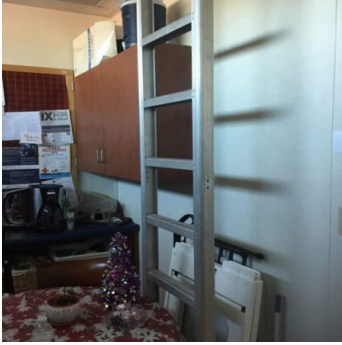
Description: Clear access to the roof ladder should be maintained at all times. Items should not be placed in front of the roof access ladder.

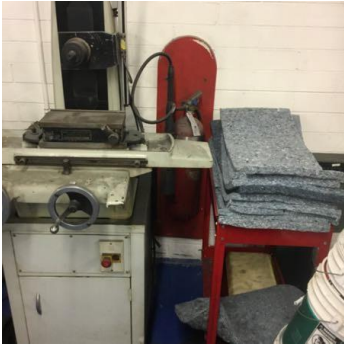
Description: Clear access to the fire extinguisher should be maintained at all times. Items should not be placed in front of the fire extinguisher.

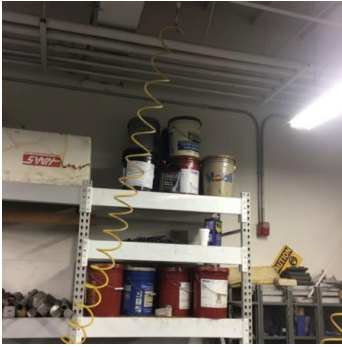
Description: 1. Heavy items stored on top of cabinets or overhead shelves present an elevated risk of struck by injuries. They can also block emergency egress if they fall to the floor. Heavy items should be stored at a

lower level to reduce this hazard. Other items stored overhead should be secured in a manner that prevents them from falling. 2. Chemicals should be stored at or below eye level to allow safe handling of chemicals. If this is not possible and higher storage is required, then an appropriately sized sturdy ladder, stool or portable step should be provided.

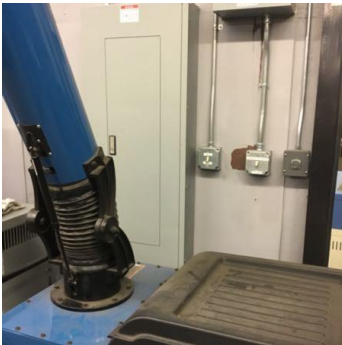
Description: A minimum 36" clearance zone should be maintained around the electrical panel(s) at all times. Excessive or improper storage of items near the electrical panel(s) may lead to inaccessibility, an increased risk of fire, and may impact the lifespan of the electrical equipment.

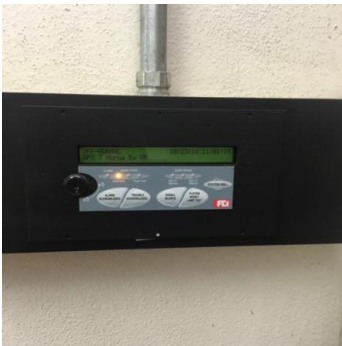
Description: The system trouble and/or system silence lights were lit on the main fire alarm panel. The fire alarm system should be operational at all times.

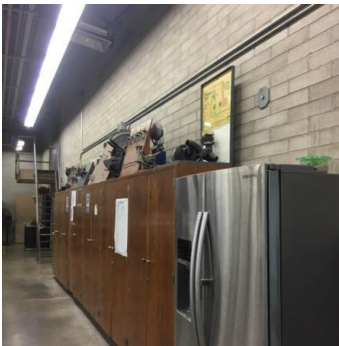
Description: The heavy items stored on top of cabinets or overhead shelves present an elevated risk of struck by injuries. They can also block emergency egress if they fall to the floor. Heavy items should be stored at a lower level to reduce this hazard. Other items stored overhead should be secured in a manner that prevents them from falling.

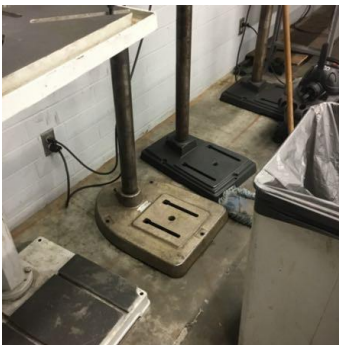
Description: Benchtop and pedestal-mounted equipment such as grinders, miter saws, and drill presses should be secured to a bench or the floor to prevent tipping.

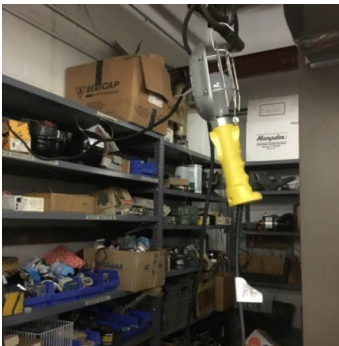
Description: The heavy items stored on top of cabinets or overhead shelves present an elevated risk of struck by injuries. They can also block emergency egress if they fall to the floor. Heavy items should be stored at a lower level to reduce this hazard. Other items stored overhead should be secured in a manner that prevents them from falling.

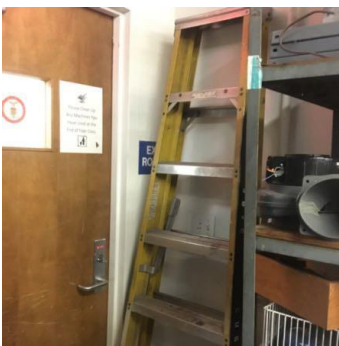
Description: Ladders should be stored secured in a manner that prevents tipping.

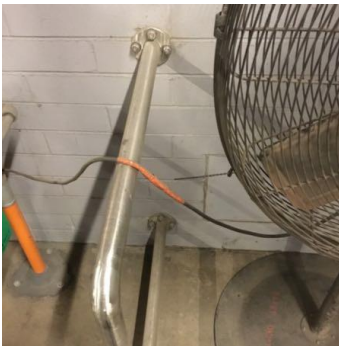
Description: The Insulation was damaged and repaired with duct tape on the electrical power cord which creates an electrical shock hazard. The power cord should be replaced with proper working power cords.
