# Volume 3

# Facilities Assessment

CRAFTON HILLS COLLEGE MASTER PLAN  
SAN BERNARDINO COMMUNITY COLLEGE DISTRICT

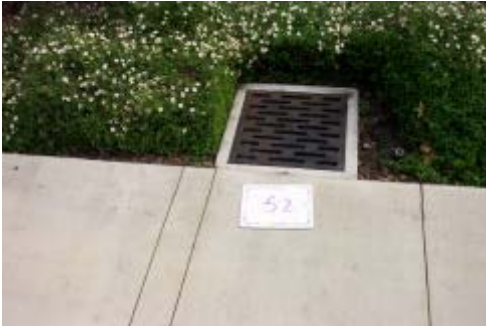
Figure 1 - Typical site catch basin that collects surface drainage.

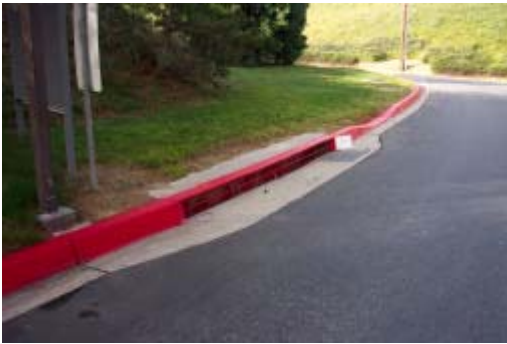
Figure 2 - Typical curb inlet located along Campus Drive.

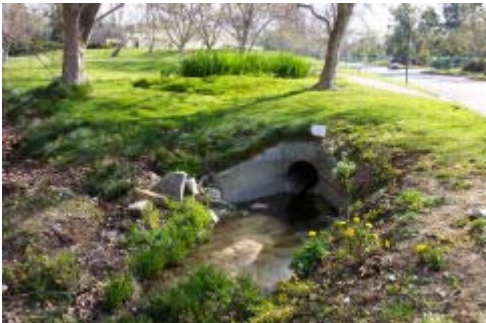
Figure 3 - Concrete headwall discharging site storm drain to open channel located along the northerly side of Campus Drive.

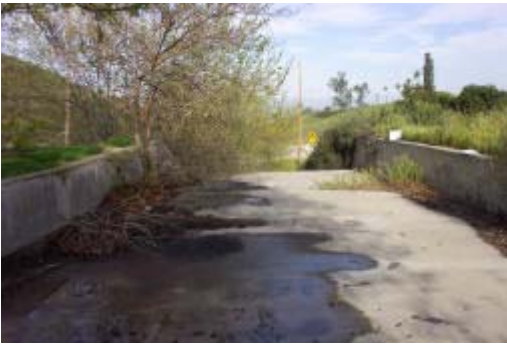
- Isolated areas adjacent to buildings that lack sufficient gradients to allow surface drainage to area drains or catch basins.
- Areas on concrete flatwork that lack sufficient gradient to direct surface drainage to catch basins.
- Catch basins and inlets appear to be in good condition and function adequately.
- Small diameter drains appear to function adequately.
- Large diameter storm drains appear to be well maintained and function properly.
- Channel located along the northerly side of Campus Drive has developed into a natural creek. The channel appears to have adequate capacity to convey site drainage. The channel requires annual maintenance to restrict growth of vegetation.
- Retention basin located in the vicinity of Campus Drive and Sand Canyon has filled with silt and is overgrown with vegetation.

Figure 5 – Retention basin spillway looking westerly downstream to Sand Canyon Road.

- Add area drains and catch basin in landscape areas where surface drainage is poor and ponding occurs.
- Replace hardscape areas where ponding occurs.
- Remove vegetation and silt from the retention basin to allow the basin to function properly.

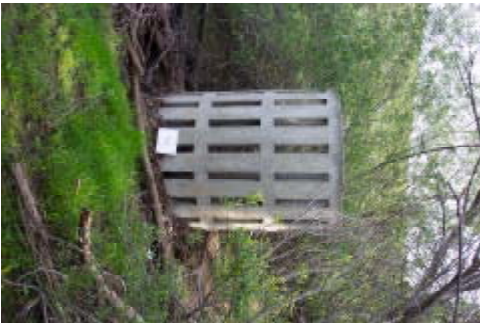
Figure 6 – Outlet structure within the retention basin.

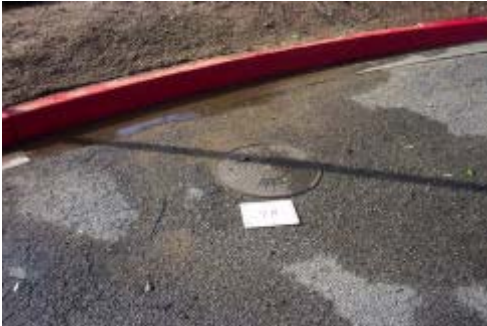
Figure 7 – Typical sanitary sewer manhole located in pavement area.

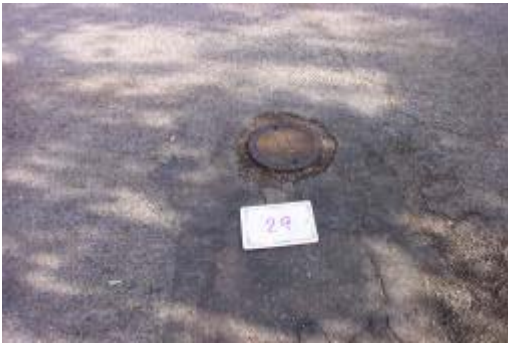
Figure 8 – Typical sanitary sewer cleanout.

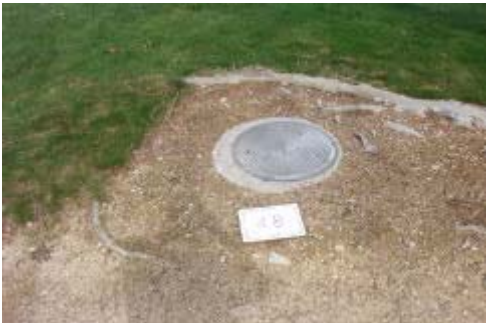
Figure 9 – Typical sanitary sewer manhole located in landscape area.

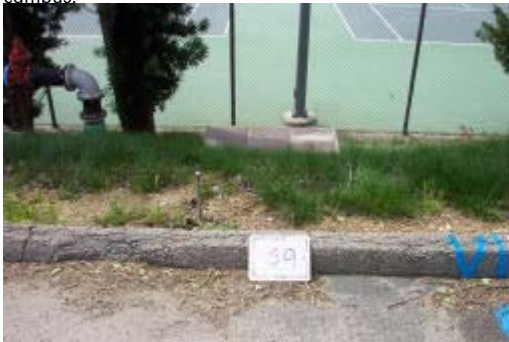
Figure 11 – Eight inch meter for campus water distribution system. Meter located at the northerly side of the tennis facility.

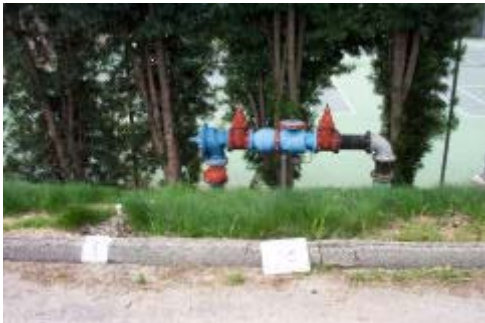
Figure 12 – Eight inch backflow device for the campus water service.

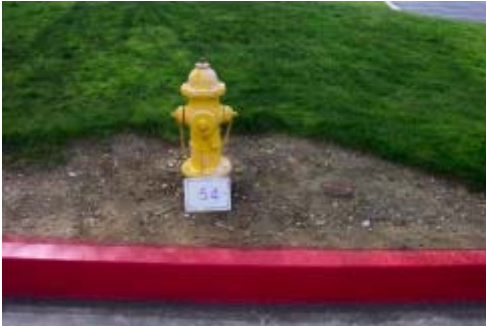
Figure 13 – Typical fire hydrant serviced from the City of Redlands transmission main located in Campus Drive.

- The water distribution system must be upgraded to accommodate current requirements for fire flow.
- A detailed study of the current water distribution system will be prepared to determine the extent to which the system is deficient.
- Water main improvements will be required.

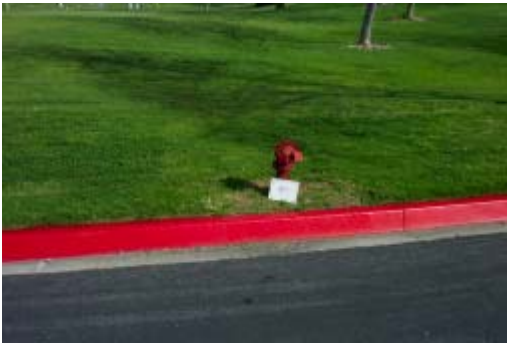
Figure 14 – Fire department connection for the fire sprinkler system for the gymnasium.

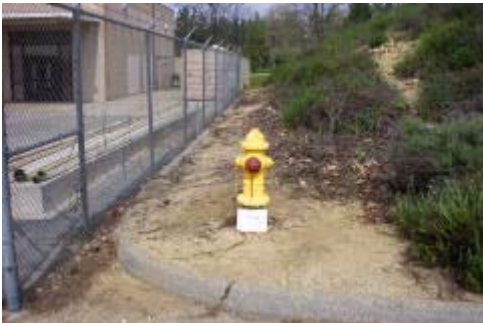
Figure 15 – Site fire hydrant serviced from the metered site water main loop.

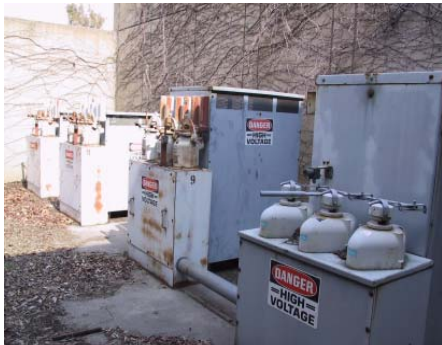
Figure 4 – Main service equipment.

- The existing high-voltage distribution equipment are discontinued models from Zinsco and G&W with no replacement parts available. However, these existing equipment are still in good working condition and require regular inspection and maintenance.

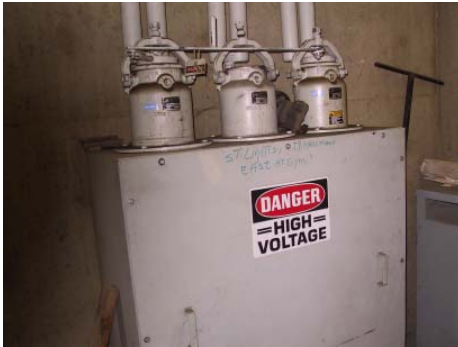
Figure 6 – Typical oil-filled fuse cut-outs.

- The existing 5KV oil-filled fuse cut-outs are discontinued models from G&W and no replacement parts are available. These equipment are in excess of their life expectancy. At this time, these equipment are still in good working condition and there is no immediate need of replacement. However, if any of the building will require renovations, replacement of all existing electrical equipment is strongly recommended.

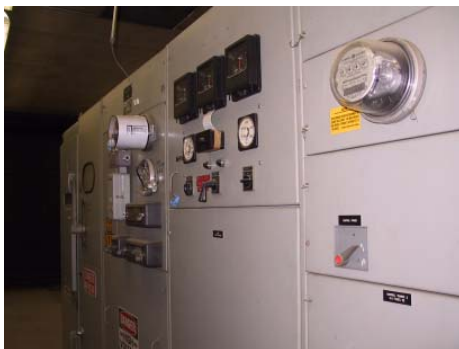
Figure 7 – Main service metal-clad switchgear.

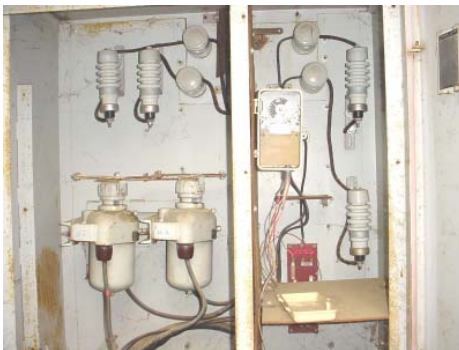
Figure 8 – Constant current transformer with oil-filled fuse cut-outs for street lighting power.

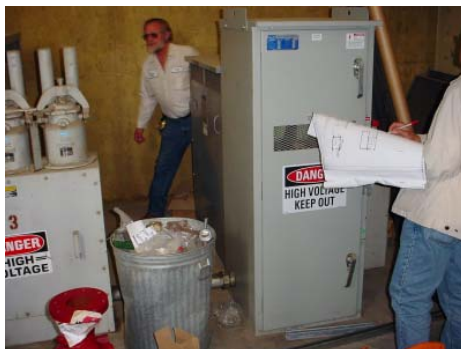
Figure 11 – Indoor service equipment.

- Building Electrical Facilities
  - With the exception of the relatively new electrical equipment in the Child Development Complex and the Bookstore Complex, electrical equipment such as panelboards and switchboards, in the older buildings are discontinued models from Zinsco with no replacement parts available. These existing equipment are in excess of their life expectancy but are still in good working condition. It is strongly recommended that should opportunity arise, such as a major building renovation, that these existing equipment be replaced. At this time, periodic inspection, and if necessary, torque adjustment of wire connections in distribution boards and switchboards are recommended.

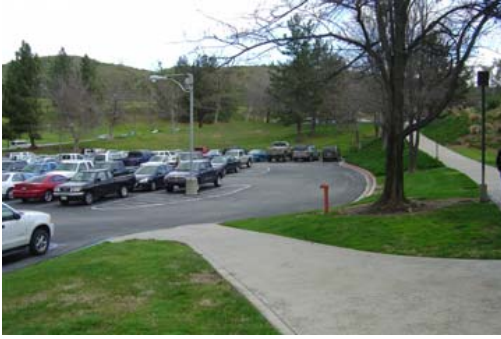
**Figure 2.4:** The landscape edge at parking lots E through I is visually open into the campus.

- The southern perimeters of parking lots E, F, G, H, and I are less steep than lots A through C. The edge planting in these lots is primarily lawn, tall fescue grass, Sycamore trees and pine trees. The perimeter is visually open to the campus and the pedestrian paths leading to buildings (Figure 2.4).

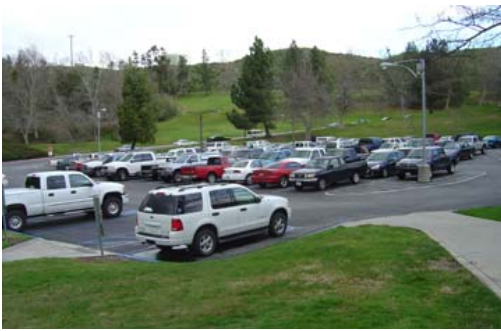
**Figure 2.6:** “Exposed Parking Lot”

- The interior islands of the “Planted Lots” are planted primarily with Evergreen Pear trees (*Pyrus kawakamii*), groundcover and lawn. The trees provide much needed shade and the planters reduce the visual and heat effect of asphalt (Figure 2.5).
- “Exposed lots” have little to no planting and accommodate a greater volume of cars (Figure 2.6). In some Exposed Lots, plant material is absent in a few, but not all, planters, suggesting the plants were removed and not replaced. The tree species in these lots tend to vary. A gravel lot located at the western end of Campus Drive is an extreme example of the Exposed Lot (Figure 2.7).

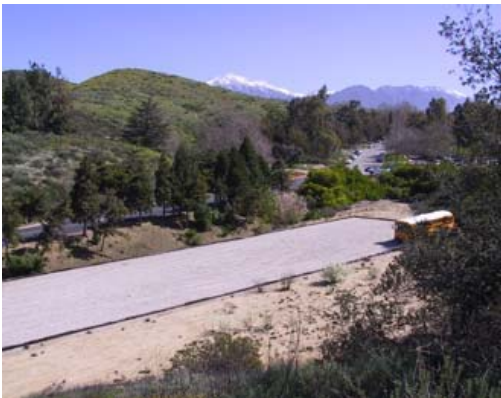
**Figure 2.7:** Gravel lot as extreme example of “Exposed Parking Lot”

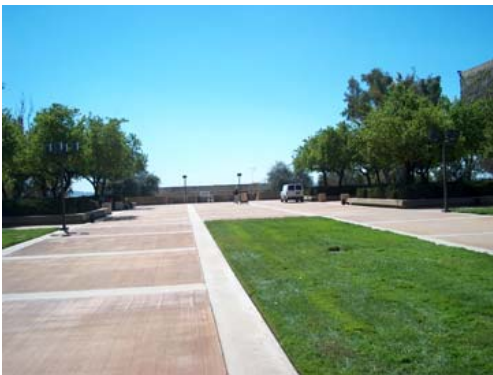
**Figure 2.9:** Lack of visual cues or focal points at Central Entry into the Quad”

- The Central Entry at Lot D lacks visual cues and a focal point. Upon entering this area, the initial view of the Central Quad is a rectangular area of lawn, leading the eye to the sky instead of a terminus or focal point (Figure 2.9). This arrival area can be greatly enhanced by the creation of a transitional area from the drop-off into the Central Quad, or a north-south axis leading to the PAC building.

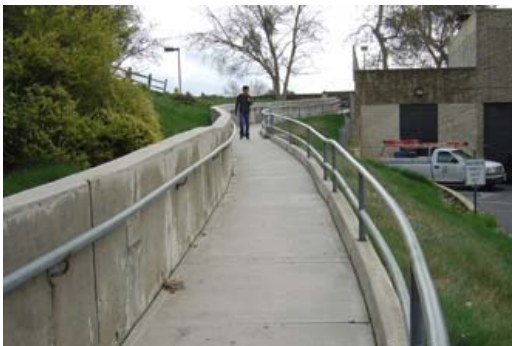
**Figure 3.5:** Ramp near LADM is not compliant with ADA standards.

- Pedestrian routes to parking lots and buildings are not always compliant with A.D.A. standards (Figure 3.5) and should be corrected in future work.
- Paving damage is evident where pedestrian walkways are used as alternative vehicular routes to buildings (Figure 2.8). Vehicular access to existing walkways can be blocked or restricted with the addition of bollards. Alternative routes for service and delivery should be identified in future work.

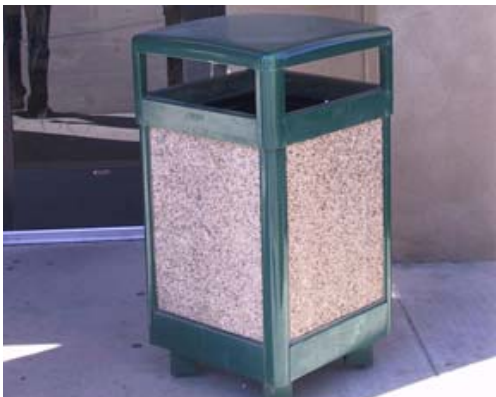
**Figure 6.8:** Trash receptacle at CDC building.

**Figure 6.9:** Metal trash receptacle.

- The College uses one particular concrete receptacle for most of the campus (Figure 6.7). This receptacle is consistent in style with the concrete tables.
- However, several other trash receptacles were observed throughout the site (Figures 6.8 and 6.9). The styles are not consistent with each other or with the primary concrete trash receptacle.
- Trash receptacles within the parking lots are recommended since litter is a problem in these areas.

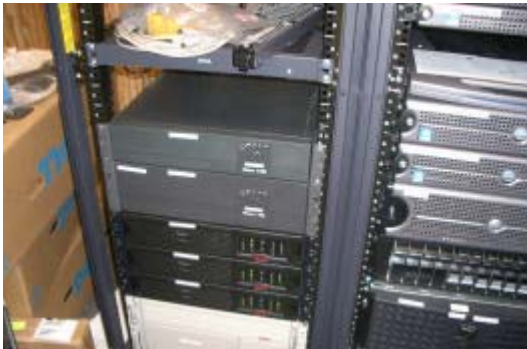
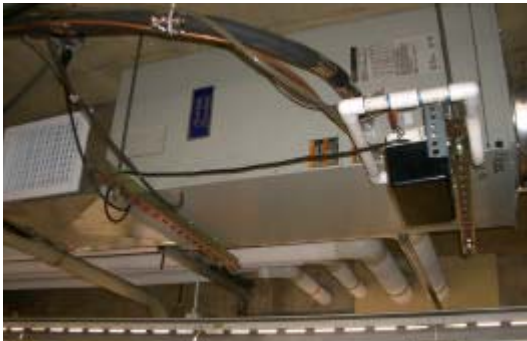
Figure 3 –UPS in data center provide back up power for the campus data network and VoIP telephone system.

Figure 4 –UPS in data center provide back up power for the campus data network and VoIP telephone system.

An additional HVAC unit was recently added to provide continued room cooling. The data center now has two independent cooling units providing a total of 9 tons of air conditioning. Back-up power in the data center is supported by individual rack mounted Uninterruptible Power Supply (UPS) associated with specific equipment. No generator exists to provide emergency power. It is recommended that an emergency generator be added.

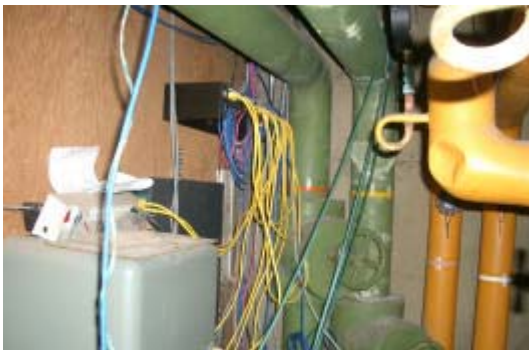
Figure 2 – Example of a worst case scenario communications equipment location - mechanical room install.

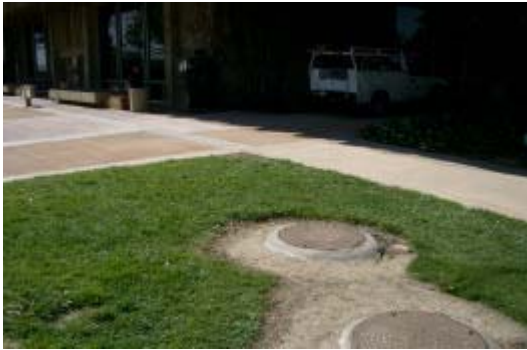
Figure 1 – Distribution from manhole connects campus communications services to data center equipment.

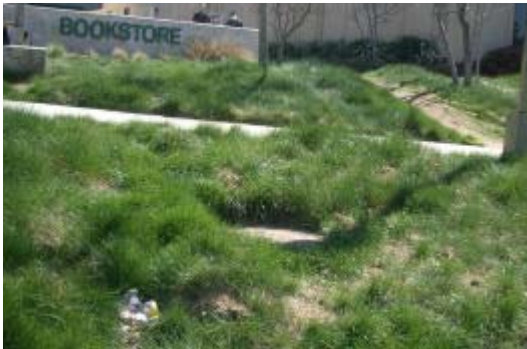
Figure 2 – Manhole location at bookstore is the southern end of campus communications infrastructure spine.

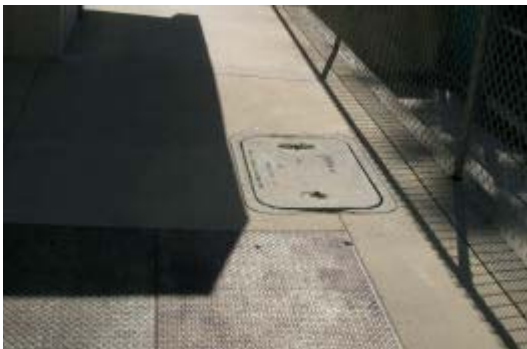
Figure 2 – Pull box at Gymnasium location. Communications cabling is routed through Electrical vault.

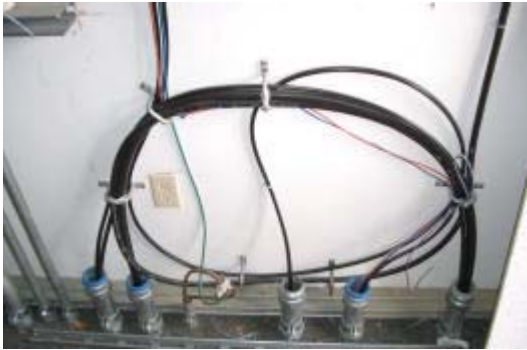
Figure 1 – Air blown optical fiber tubes extend from campus infrastructure to building equipment rooms, as seen here.

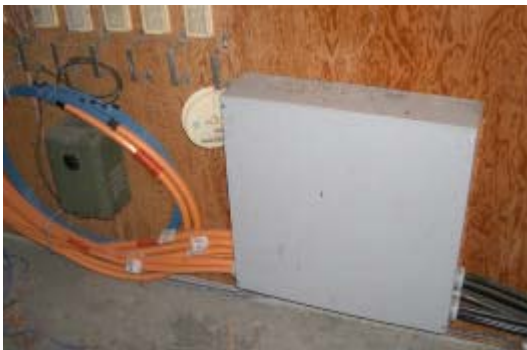
Figure 2 – Air blown optical fiber tubing originates here in the Library/LRC building.

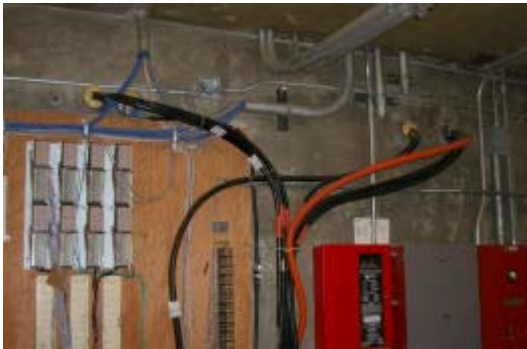
Figure 3 – Backbone cabling and fiber tubes exit the Library basement

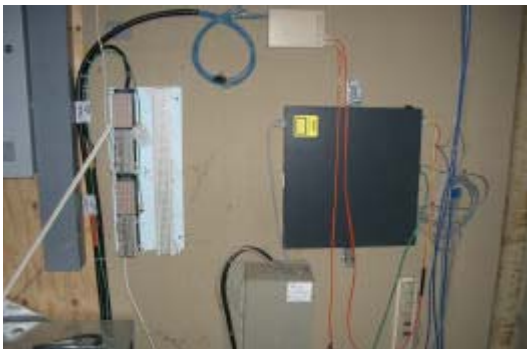
Figure 4 – Communications equipment room with wall-mounted campus backbone cabling (copper & fiber).

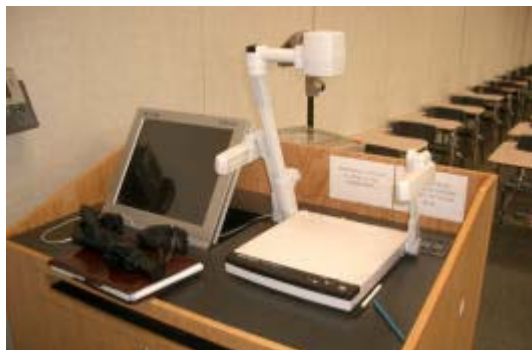
Figure 1 – Example of newer instructor media station with dedicated computer and document camera.

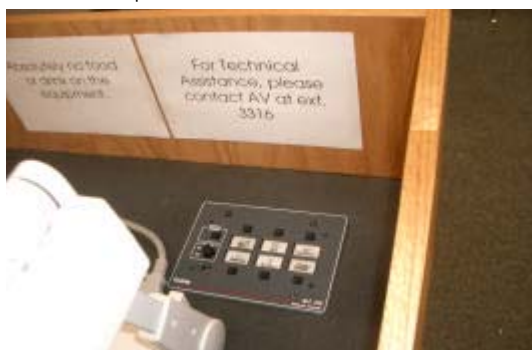
Figure 2 – Push button AV control panel at instructor station allows for equipment selection and volume control.

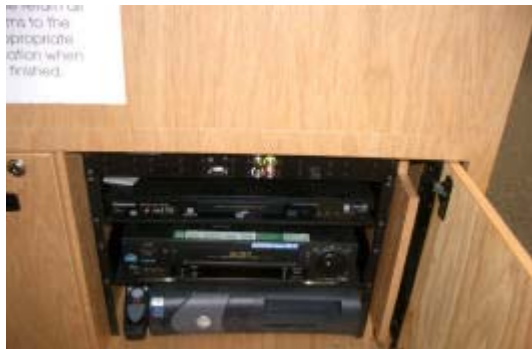
Figure 4 –Instructor station DVD and VHS source equipment. Source images are displayed via ceiling mounted

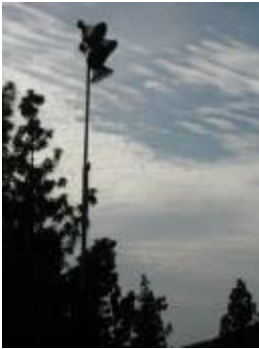
Figure 1.6 – Sports field – Portable floodlights inadequately illuminate area.

- Around building perimeters these were predominantly acceptable. However, notable exceptions included:
  - Stairs at some locations are not specifically illuminated, posing a trip hazard.
  - The sports field is only illuminated using portable light fixtures, which could potentially lose power during use.

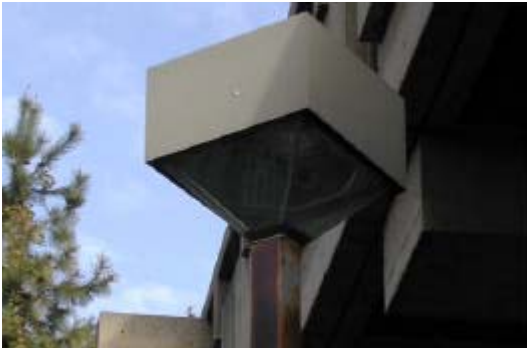
Figure 2.2 – Post top at top of stairs – Pedestrians see into fixture when ascending stairway.

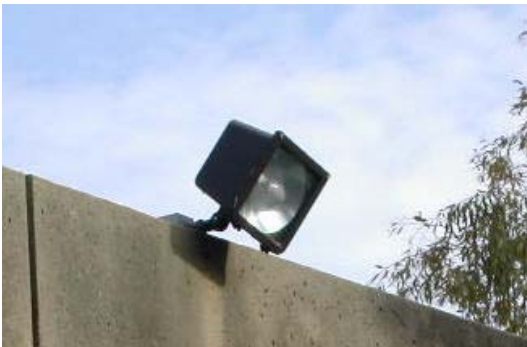
Figure 2.3 – Student Services – floodlight illuminating stairs partially blinds pedestrians.

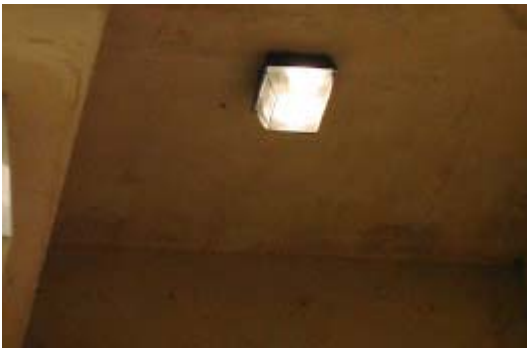
Figure 2.4 – Ceiling mount fixture – where visible, fixture is major source of glare.

- Fixtures using visible lamps (including pole lights, wall packs, and floodlights) actually reduce visibility.

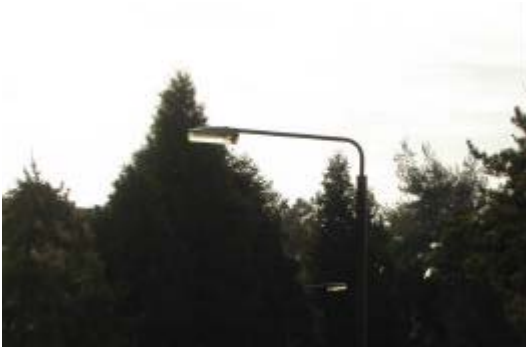
Figure 3.1 – Street lighting – low pressure sodium source emits light in only two wavelengths.

- Low pressure sodium is currently being replaced by induction lamp fixtures in parking lots and roadways. Low pressure sodium is the absolute worst color rendering source available and should only be used where required by nearby observatories, etc.
- High pressure sodium is being used in wall packs at some locations (Childhood Development, etc.) This renders most colors as gold or brown.
- Metal halide, fluorescent, and incandescent sources throughout the site use moderate to good color rendering lamps.

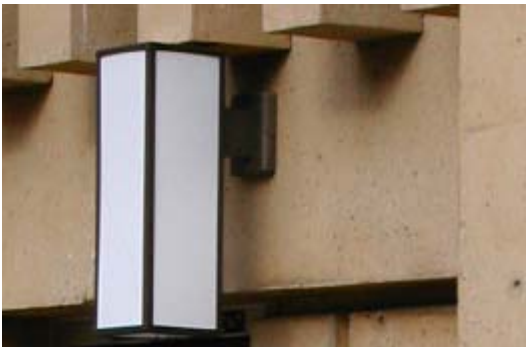
Figure 3.3 – New wall sconces – These use fluorescent, for moderate to good color rendering.

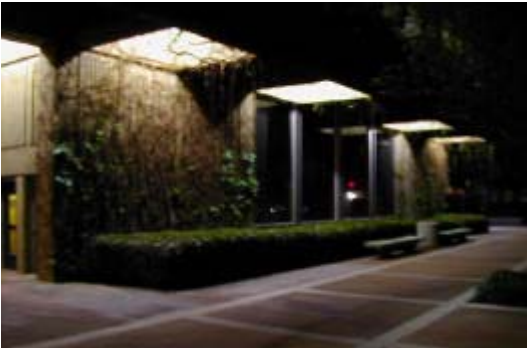
Figure 4.2 – Building integrated lighting serves to illuminate building as backdrop + surrounding.

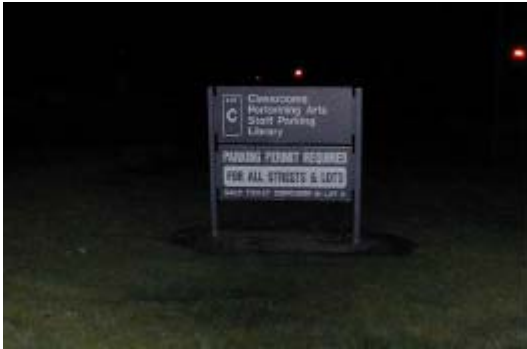
Figure 6.1 – Parking signage – illuminated only by vehicular headlights

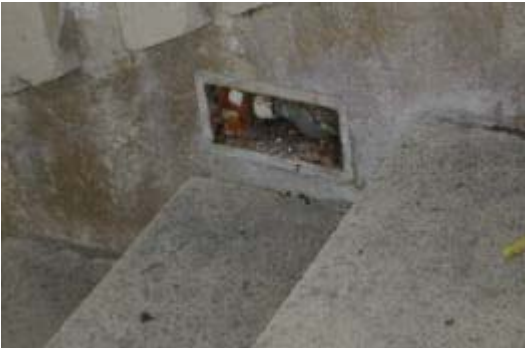
Figure 7.2 – Most older lensed steplights are no longer functioning.

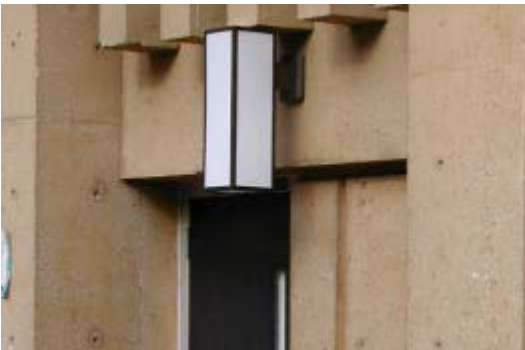
Figure 7.3 – New sconces do not employ screws or other fasteners to hold bottom panel in place..

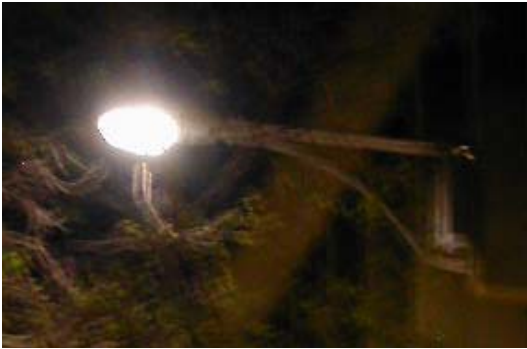
Figure 9.2 – Fixtures cannot store enough energy to last entire night during the winter.

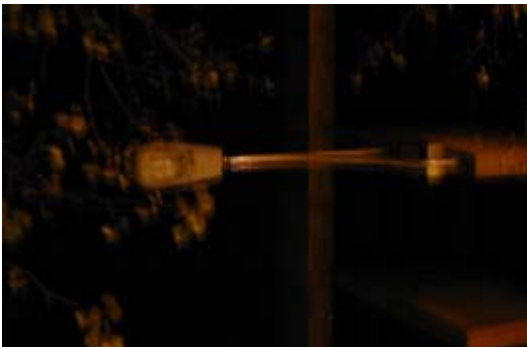
Figure 9.3 – Some fixtures currently not operating at all.

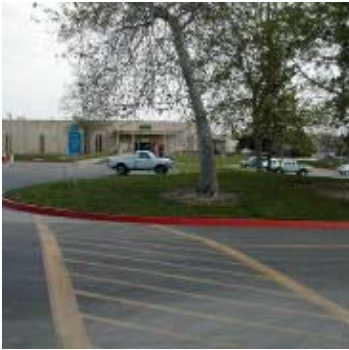
Figure 2.5 – Crosswalks on campus are currently poorly illuminated.

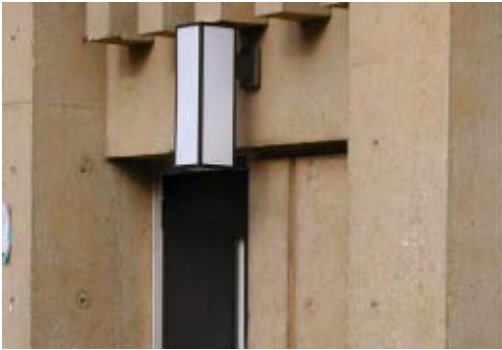
Figure 7.1 – Non-vandal resistant fixtures should not be used where they are in easy reach.

- Non-vandal resistant fixtures be replaced
  - with vandal resistant fixtures, or
  - with fixtures out of easy reach
- Non-cut off fixtures be replaced with full cut-off fixtures to assist in LEED accreditation. Any area lighting fixtures on new buildings will have to incorporate cut-off optics in order to comply with Title24 2005.
- Fluorescent, induction lamp, and/or ceramic metal halide sources be used for their superior color rendering.

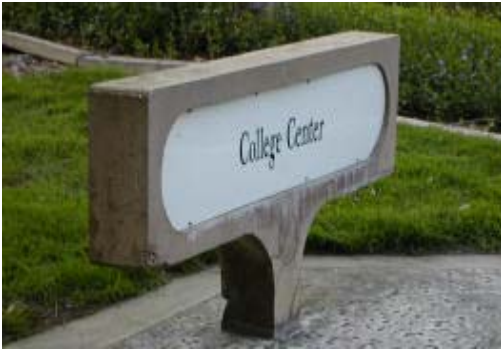
Figure 10.1 – Existing building signage is internally illuminated, although unevenly.

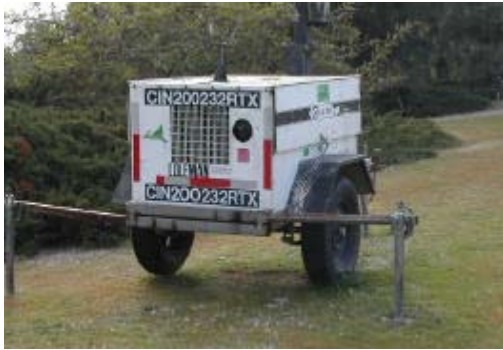
Figure 11.1 – Existing lighting consists of gas-powered construction floodlights.

- glare
- very harsh shadowing
- inadequate illumination
- likelihood of power failure (running out of gas)

If this area is to be used during evening hours, a proper sports lighting system is recommended.

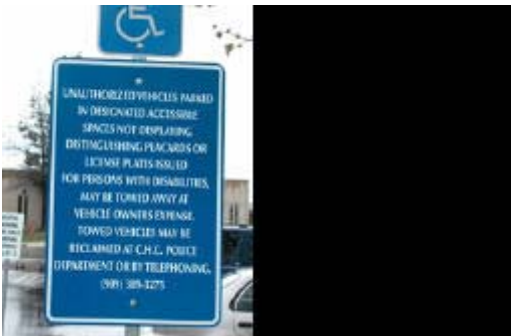
Figure 4 – View of accessible parking entry sign. Typical at all parking lot entrances.

Replace existing signage with clear and concise graphics and message. Sign should be reduced in scale and can incorporate accessible parking entry sign message (see figure 4). The accessible parking code information is only required at the two entry points of the campus and is not required at each parking lot entrance.

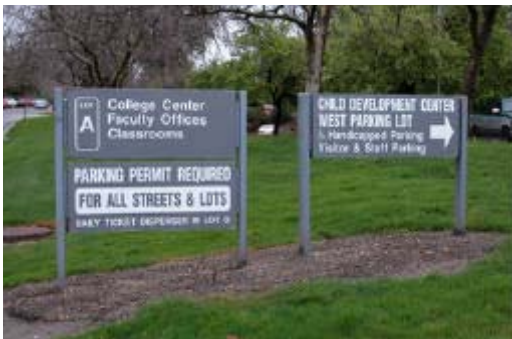
Figure 6 – View of parking lot “A” identification sign with added directional sign.

Figure 6: Multiple signs appear at the same location with different messages. One sign is parking lot identification and the other is a building and lot directional sign.

Replace existing signage with new signage system. Lot identification and building identification graphics should be the most important message. Minimize the size of the parking permit information or remove it to another sign. Include additional directional information within the same sign.

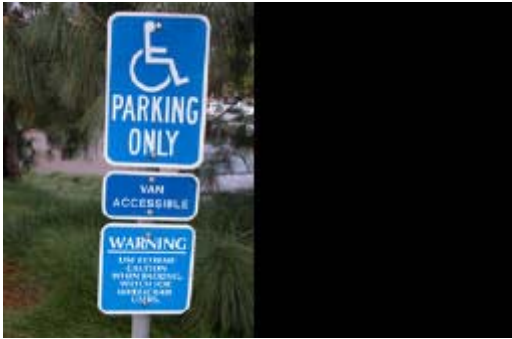
Figure 9 – View of typical accessible parking stall sign.

Replace all regulatory signs with new signage system of matching color, graphics and design. Provide wheel stops at end of stalls to eliminate bent poles.

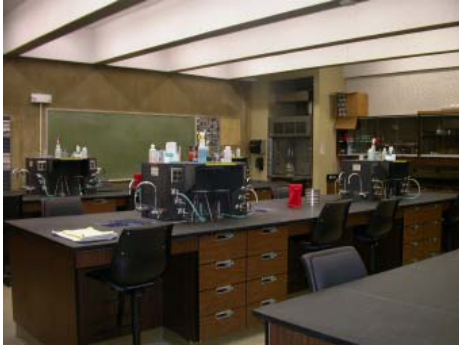
**Lab 201** - Non-compliant seating and fixtures.

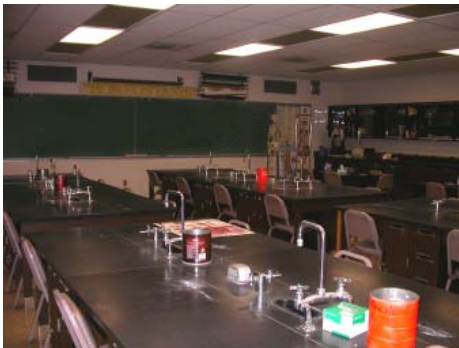
**Lab 225** - Non-compliant seating and fixtures; low light levels.

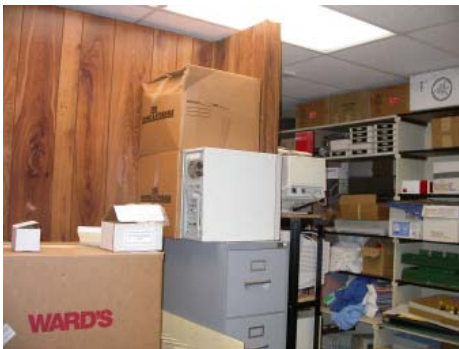
**Storage room** - Temporary partitions have been installed that render room inaccessible.

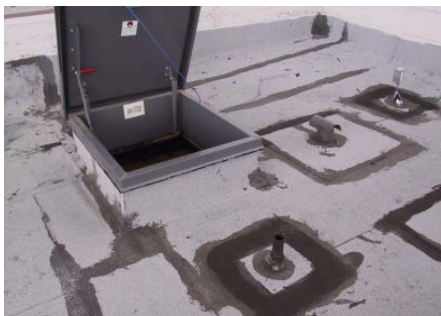
**Figure 4** – Example of a plumbing vent less than 3'-0" away from a building opening.

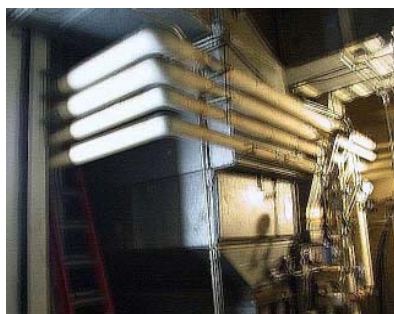
**Figure 2** – Example of no seismic bracing on the piping or the duct work.

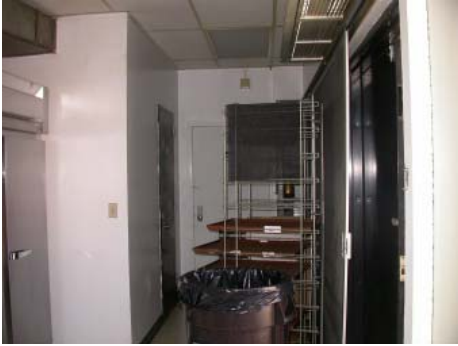
**Kitchen** - Lack of storage means bulky items are kept in pathways.

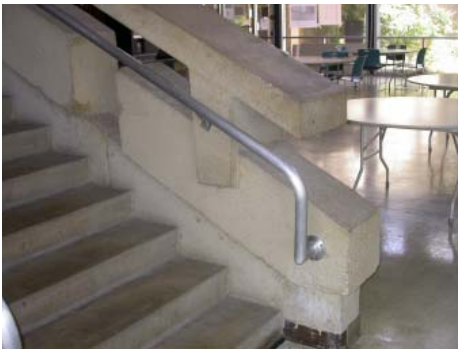
**Stairs** - Handrail extensions do not comply with code; top and bottom tread lack contrast warning strip.

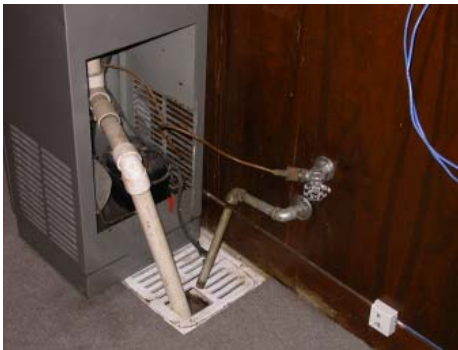
**Crafton Center** - Exposed piping and floor drain.

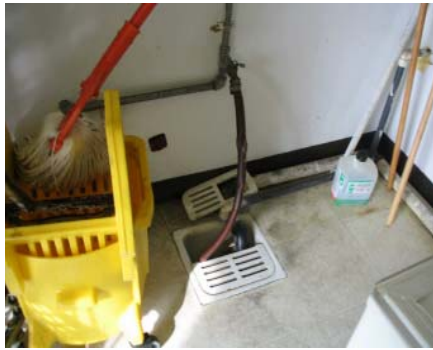
A hose bibb without vacuum breaker, hose connects to hosebibb and drops into floor sink.

- Provide and install half or  $\frac{3}{4}$  grating over all floor sinks.
- Provide new hose bibs to replace existing, or install vacuum breakers at all existing hose bibs.

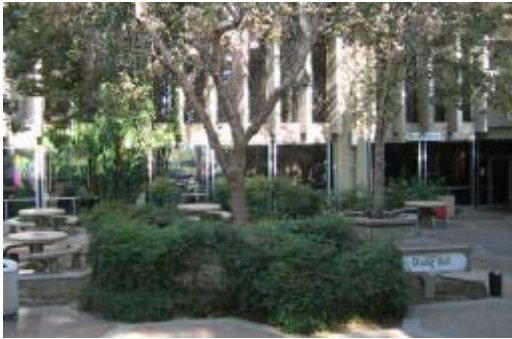
Figure 1 – View of Student Center/Cafeteria building.

Existing freestanding illuminated concrete sign is showing signs of decay. Scale of the sign and its copy is too small for larger buildings. Concrete sign is not visible as it blends with concrete architecture. Illuminated sign panel is too small to identify buildings with several names, uses or departments. Exposed screws are visible in sign face. Illuminated faces do not provide the best copy visibility.

Repair concrete and sandblast to clean. Retrofit lamping and wiring. Replace acrylic panel with painted aluminum panel with routed out copy so that just the copy illuminates.

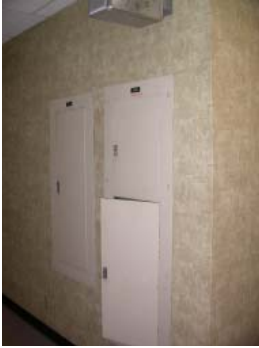
**Hallway** - Exposed and unlocked electrical panels.

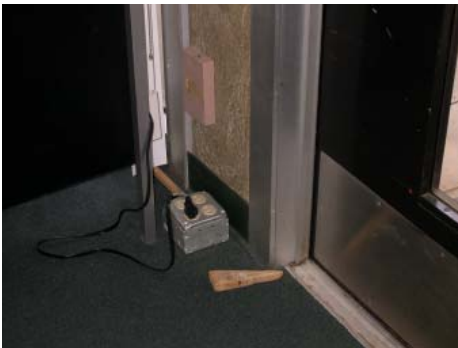
**Office** - Electrical outlet not mounted or secured.

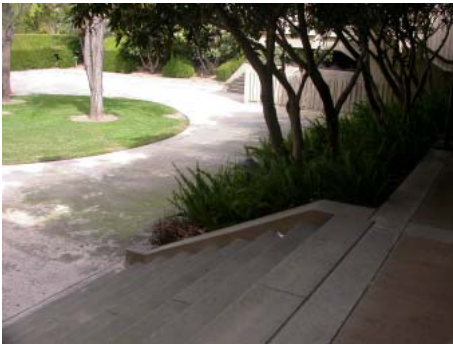
**Exterior stair** - No handrail.

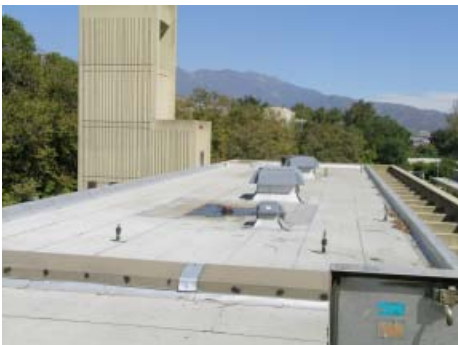
**Student Services A roof** - Signs of ponding.

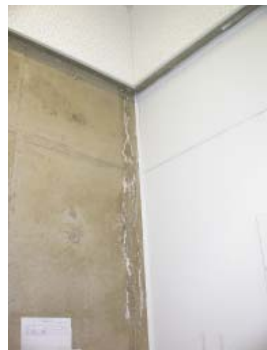
**Water damage at wall**
