# Volume 3

# Facilities Assessment

CRAFTON HILLS COLLEGE MASTER PLAN  
SAN BERNARDINO COMMUNITY COLLEGE DISTRICT

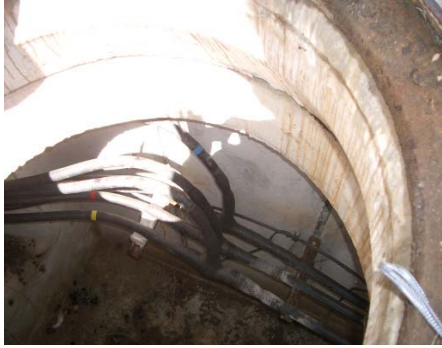
Figure 1 – Electrical manhole.

- Campus High-Voltage Distribution System
  - Main issue with the majority of the manhole is the water running into it. Almost every manhole is half-filled with water. It is recommended that all manholes be looked at to determine how water accumulation can be prevented.

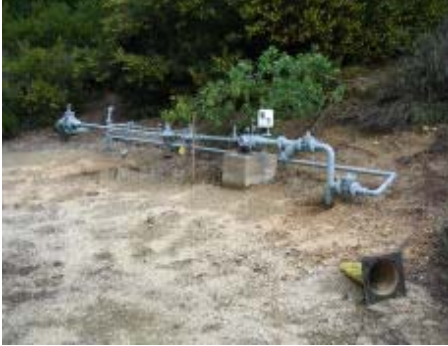
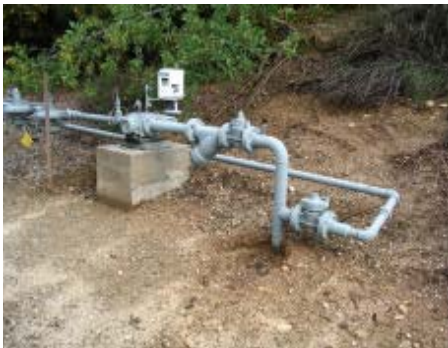
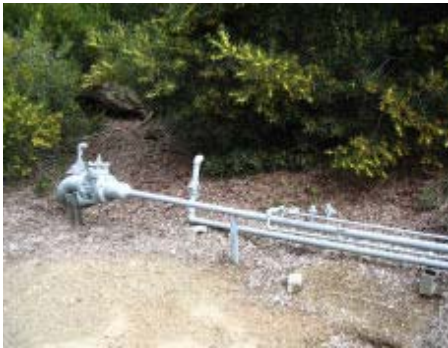
- The master gas meter is located on west of the campus.
- High pressure gas is supplied to the meter by Gas Company. Gas Company's gas pressure regulators reducing the pressure to 3 to 5 PSI (to be verified).

- A 6" painted gas line appears to be black steel enters underground and delivers gas to the campus.
- Above ground piping appears to be in fair condition.

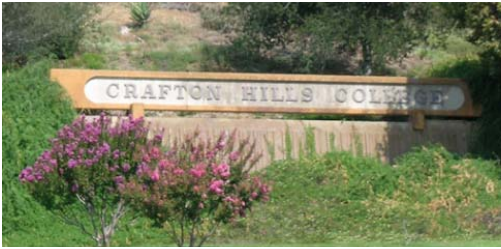
**Figure 2.1:** College Marquee at Southern Entrance along Sand Canyon Road

- A secondary system of roads provides service access to the existing buildings (Diagram 1).
- College marquees identify the Sand Canyon Road entries and the College's central entry at parking lot D (Figure 2.1 and Diagram 1). The marquees are clearly visible from the road and serve well as campus identification signs. However, the plantings surrounding the signs do not reinforce a strong gateway concept.

- Enhancement of the landscape along Campus Drive and at the marquee gateways can make the campus entry more welcoming and memorable for visitors. The three marquee gateways can share a more distinct and related design that visually connects them to each other and better defines each one as a destination marker.
- Secondary/service roads do not extend to all buildings. Even if the road connects to a building, it is not always the most direct route, as seen with the Performing Arts Center loading dock. College personnel and delivery drivers will use pedestrian walkways as alternative routes to gain closer access to buildings, resulting in damage to paving, plants and equipment (see Figure 2.8).
- Parking lot entrances/exits get congested when traffic volume is high.

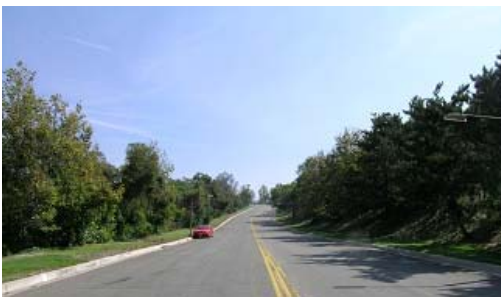
**Figure 2.2:** Campus Drive

- Mass plantings of native and non-native trees and shrubs border either side of Campus Drive at the College entries (Figure 2.2). As an entry drive, the landscape lacks definition or visual cues.

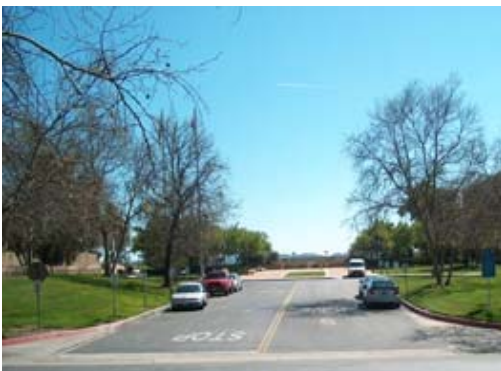
**Figure 2.3:** Central Entry at Parking Lot D

- The Central Entry at parking lot D includes limited parking, a bus stop and visitor drop-off area (Figure 2.3). The marquee sign identifies this arrival point, but the space lacks visual impact. Although visitors enter the heart of the campus, (i.e., the Central Quad) from this point, they will not be aware of this until they stand in the middle of the Central Quad.

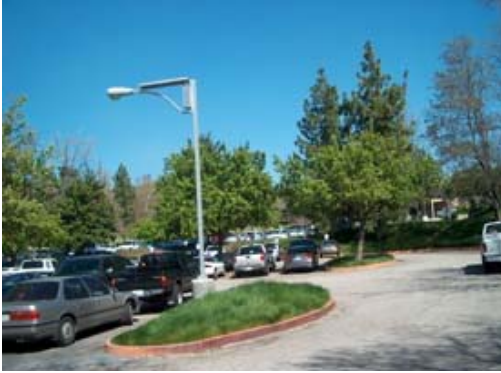
**Figure 2.5** – “Planted Parking Lot”

- The interior islands of the “Planted Lots” are planted primarily with Evergreen Pear trees (*Pyrus kawakamii*), groundcover and lawn. The trees provide much needed shade and the planters reduce the visual and heat effect of asphalt (Figure 2.5).
- “Exposed lots” have little to no planting and accommodate a greater volume of cars (Figure 2.6). In some Exposed Lots, plant material is absent in a few, but not all, planters, suggesting the plants were removed and not replaced. The tree species in these lots tend to vary. A gravel lot located at the western end of Campus Drive is an extreme example of the Exposed Lot (Figure 2.7).

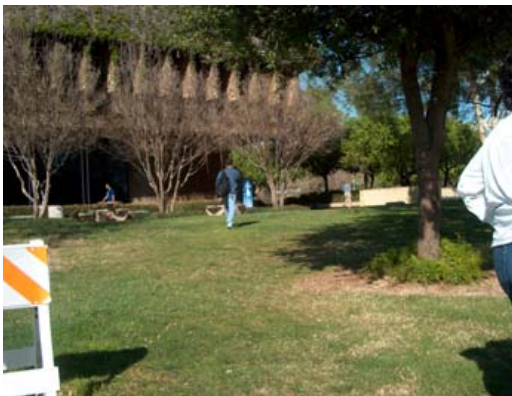
**Figure 3.3:** Students cut across lawn near Library to avoid less direct routes.

- Pedestrian walkways do not always transcend the most direct routes, encouraging students to create “cow paths” through the landscape (Figure 3.3). The cow paths are most obvious near the parking lot areas (Figure 3.4). New walkways can be installed where landscape areas are most damaged.

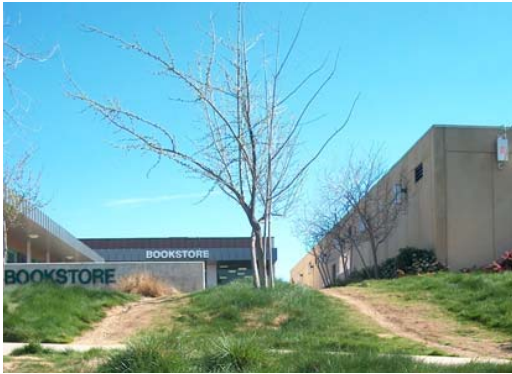
**Figure 3.4:** “Cow path” between Parking Lot G and the Bookstore.

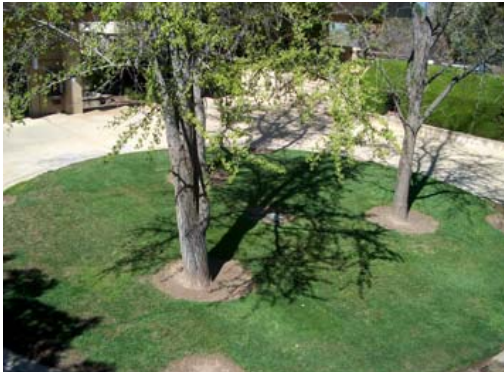
**Figure 4.8:** The SSA Green with its lawn area and Ginkgo trees

- The lawn in the SSA Green is a maintenance issue since mowers must be carried up and down the steps (Figure 4.8). Replacing the lawn with groundcover or hardscape material can alleviate this problem.

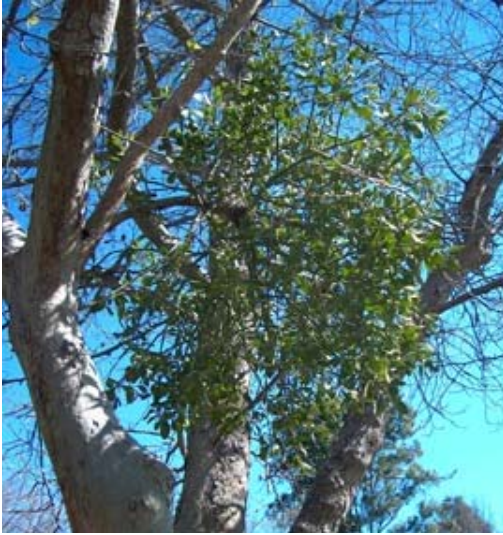
**Figure 4.9:** Mistletoe growing on Sycamore tree

- Campus trees suffer from horticultural pests and diseases. Mistletoe (a parasitic plant observed on Sycamore trees), psyllid (a pest attacking Eucalyptus trees) and fire blight (a bacterial disease affecting the Evergreen Pear trees) are current problems (Figure 4.9). If the diseases/pests are not horticulturally managed, trees can be weakened and sometimes killed, especially if they are stressed by other problems such as drought. We recommend the College hire a certified arborist to assess tree conditions. An arborist can determine the extent of damage to infected trees and make recommendations regarding their disposition.

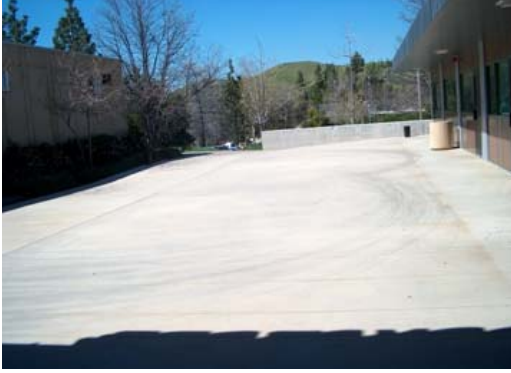
**Figure 5.7:** Bookstore Court feels void of people, seating and shade.

- The College has a variety of outdoor spaces, but most seem underutilized. Activating these spaces will require the development of more scheduled events for the spaces and the addition of amenities that maximize user comfort (shade trees, seating, shade structures). The Bookstore Court, for example, is so void of amenities that it feels empty and overly exposed to the elements (Figure 5.7).

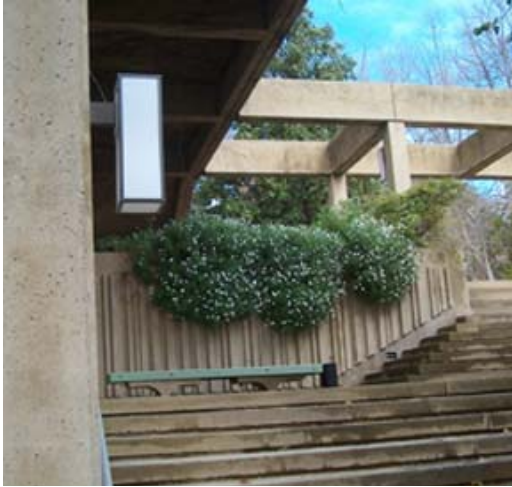
**Figure 5.8:** Stairs and landings become “Found Spaces”.

- Due to the lack of site furnishings in many of the outdoor spaces, students take advantage of “found spaces,” such as stairs and landings, for informal gatherings (Figure 5.8). They also sit on the guard walls located outside of their classrooms (Figure 5.9). Since these guard walls protect people from the sometimes steep adjacent slope, its use as seating should be a safety concern.

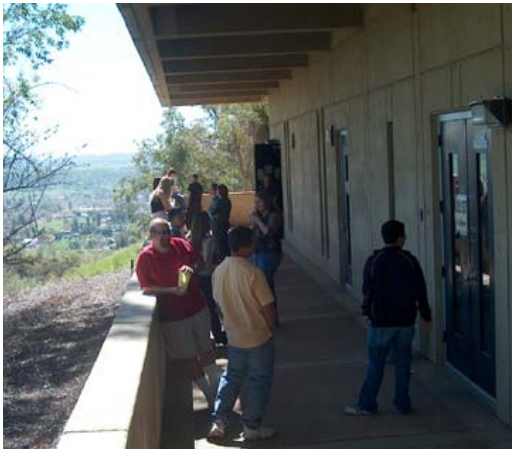
**Figure 5.9:** Students use guard walls for seating between classes.

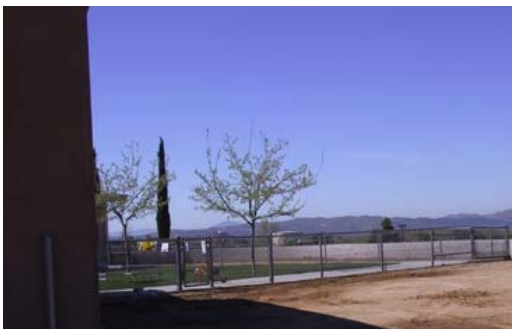
**Figure 5.10:** Low fencing surrounding the Child Development playground.

- The Child Development buildings include a large children’s playground area. This playground is a unique space within the campus. The playground is partially bordered by a fence that seems too low for security purposes (Figure 5.10). A landscape hedge would enclose and provide a green buffer.

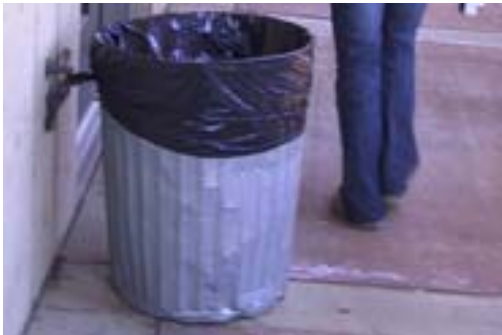
**Figure 6.8:** Trash receptacle at CDC building.

**Figure 6.9:** Metal trash receptacle.

- The College uses one particular concrete receptacle for most of the campus (Figure 6.7). This receptacle is consistent in style with the concrete tables.
- However, several other trash receptacles were observed throughout the site (Figures 6.8 and 6.9). The styles are not consistent with each other or with the primary concrete trash receptacle.
- Trash receptacles within the parking lots are recommended since litter is a problem in these areas.

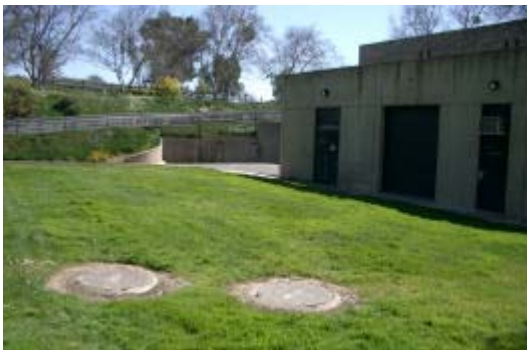
Figure 2 – Incoming services route through manhole located at the LADM building.

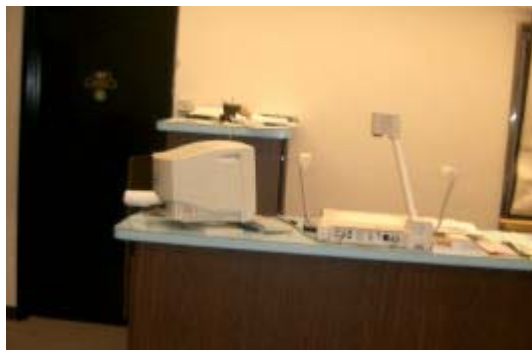
Figure 3 – Example of legacy instructor station, generally larger in size.

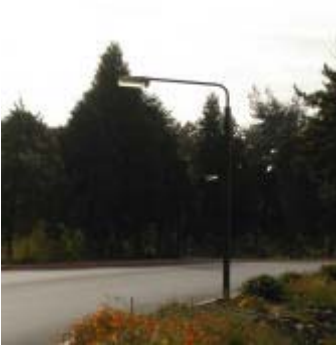
Figure 1.1 – Street lighting - restricted height and wide spacing lead to uneven lighting.

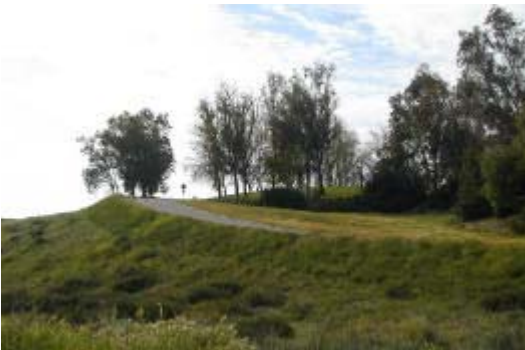
Figure 1.4 – Service road - unilluminated

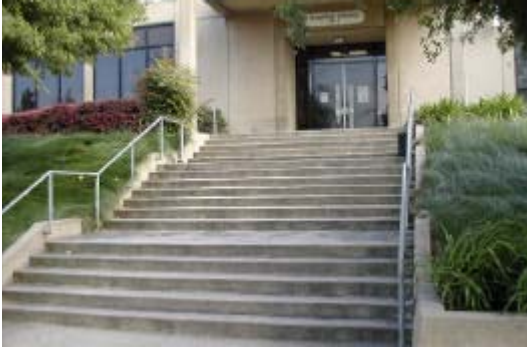
- Stairs at some locations are not specifically illuminated, posing a trip hazard.
- The sports field is only illuminated using portable light fixtures, which could potentially lose power during use.

Figure 1.5 – Bookstore - Stairs illuminated by building mount fixtures (off during site walk.)

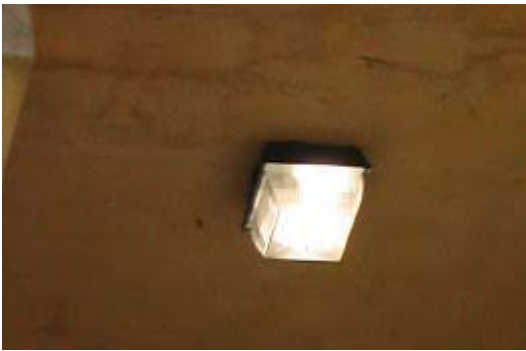
Figure 3.2 – Metal halide – this is a moderate to good color rendering source.

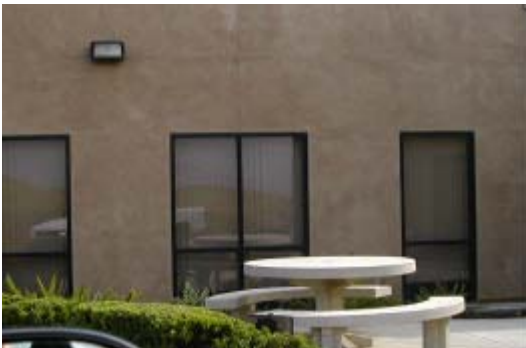
Figure 3.4 – High pressure sodium – Environments appear various shades of gold and brown.

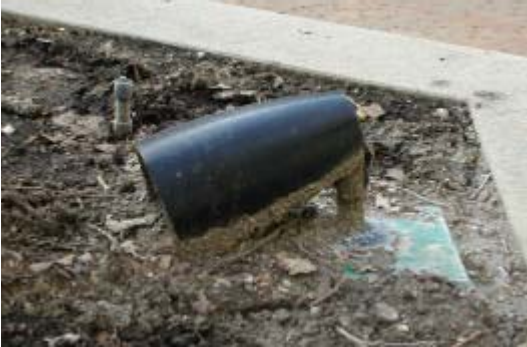
Figure 5.1 – Landscape uplight is a source of light pollution, when functional.

- No functioning landscape lighting currently exists, leading to dark surroundings to campus.
- Nonfunctioning bullet uplights would be source of light pollution if operable.

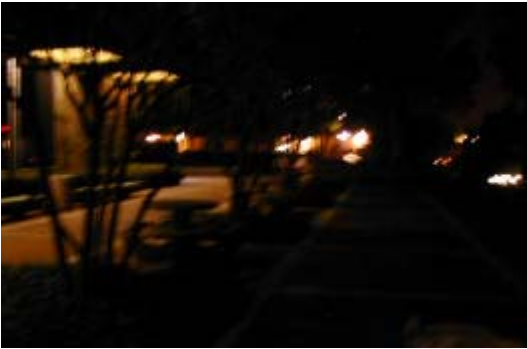
Figure 5.2 – Non-illumination of landscape surroundings leads to dark areas.

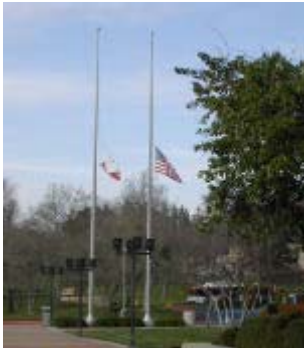
Figure 6.2 – Flags – currently unilluminated

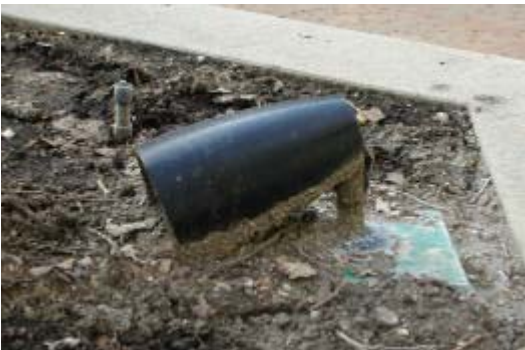
Figure 7.4 – Ground mount landscape lighting should be provided as durable floodlights.

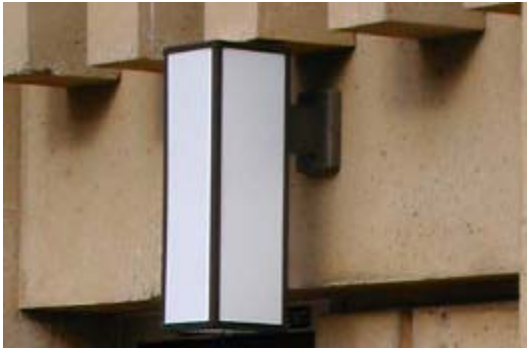
Figure 8.2 – Fluorescent sconce – Light is scattered in all directions.

- Most fixtures on site do not use cut-off optics, causing a lot of light to be discharged directly into the night sky.
- Many newly installed fixtures do not use optics at all but simply scatter light in all directions.

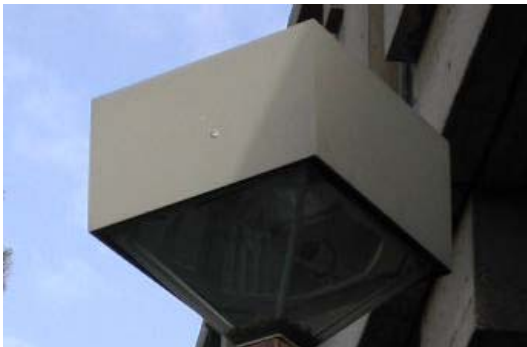
Figure 8.3 – Cut-off optics – Light is directed only below horizontal

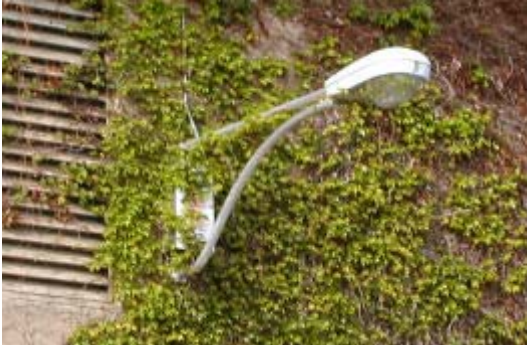
Figure 9.1 – Cobra head fixtures collect solar energy during the day.

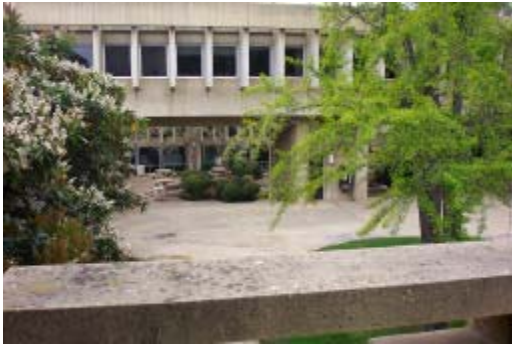
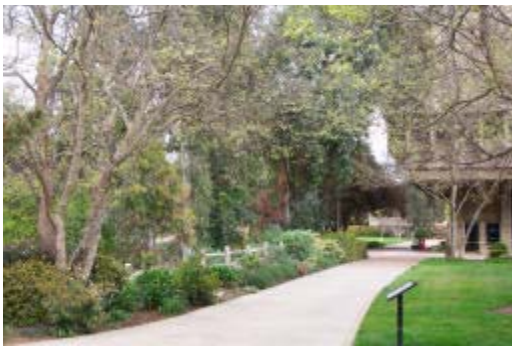
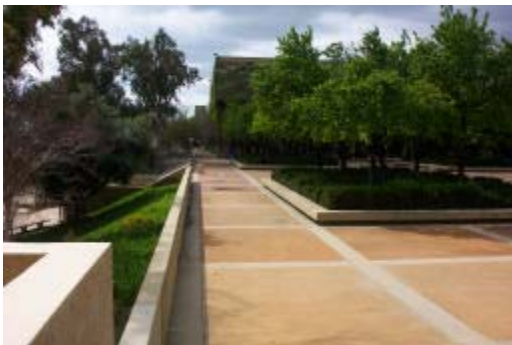
Figure 1 –Toward 03-Student Center / Cafeteria

Figure 2 –Westward, toward 02-Library.

Figure 4 –Westward, toward the 02-Library

- The Campus does suffer from expansive landscaping that is a hindrance to exterior CCTV coverage. (See figures 1-4)

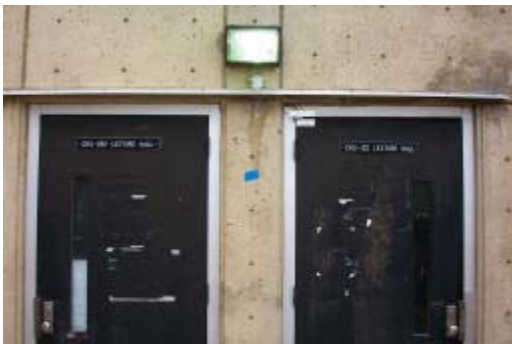
Figure 2 – Light on over Lecture Hall doors at 2:30 PM, on a Sunday.

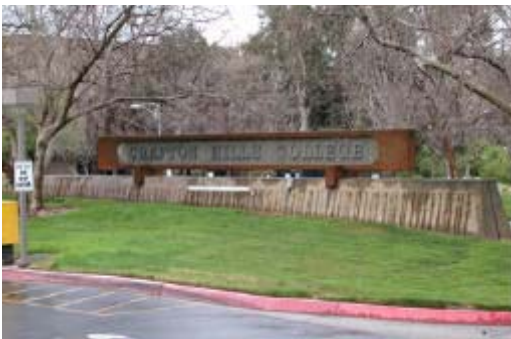
Figure 2 – View of project monument at center of campus.

Existing signs are showing signs of decay. Concrete is cracking and concrete color stain is fading. Letter finish is faded. Illumination is inadequate to light entire sign element. Landscaping is incomplete or is in need of maintenance.

Refinish and repair concrete structure. Refinish existing letters and provide higher degree of contrast to the background. Replace illumination with continuous lighting mounted at base and concealed within landscaping. Provide, replace or repair landscaping.

Replace existing signage with new monuments, lighting and landscaping.

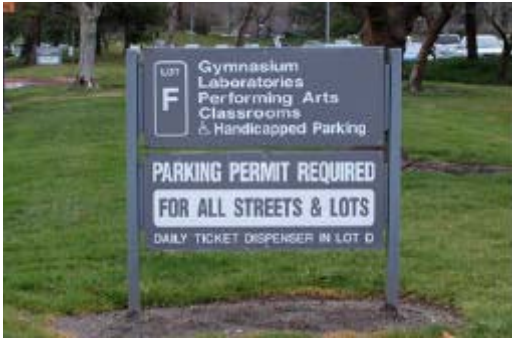
Figure 5 – View of typical parking lot identification sign.

Replace existing signage with new signage system. Lot identification and building identification graphics should be the most important message. Minimize the size of the parking permit information or remove it to another sign. Include additional directional information within the same sign.

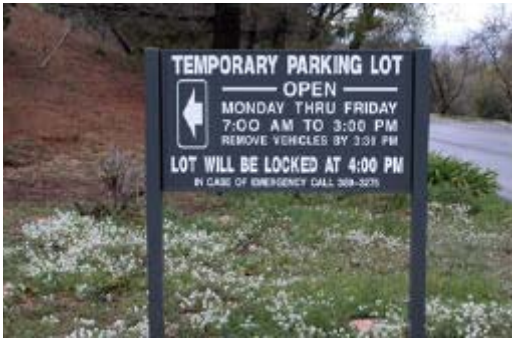
Figure 7 – View of temporary parking lot sign.

Figure 7: Temporary lot sign does not match other signage.

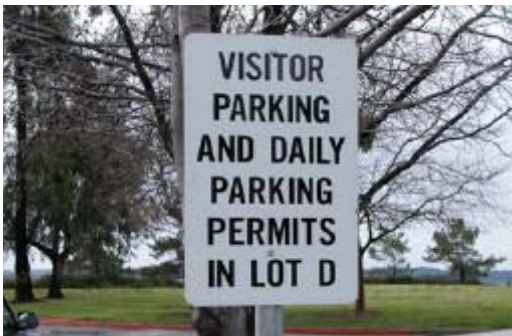
Figure 8 – View of typical parking permit information.

Figure 8: Multiple parking permit information signs appear throughout the lot although the same message appears on the parking lot identification sign at the entrance.

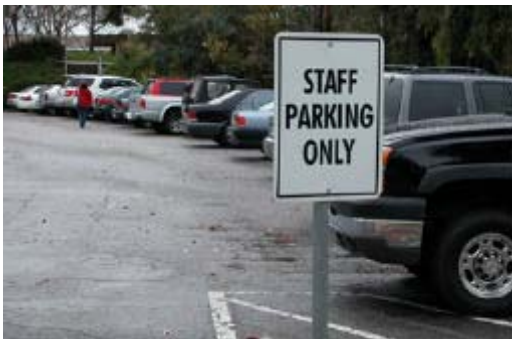
Figure 10 – View of typical staff parking sign.

### Pole Mounted Regulatory Signs (see figures 9 - 12)

Replace all regulatory signs with new signage system of matching color, graphics and design. Provide wheel stops at end of stalls to eliminate bent poles.

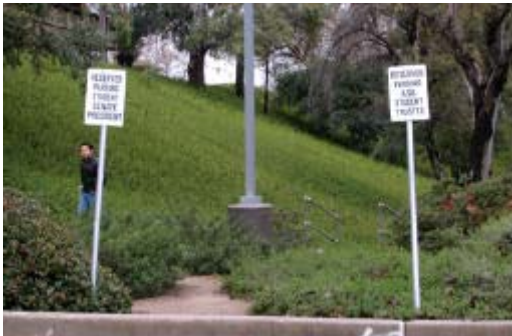
Figure 11 – View of reserved parking stall sign.

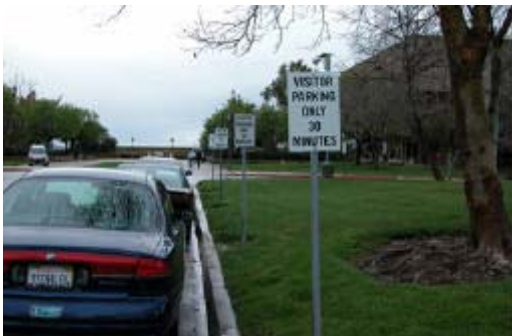
Figure 12 – View of visitor parking stall sign.

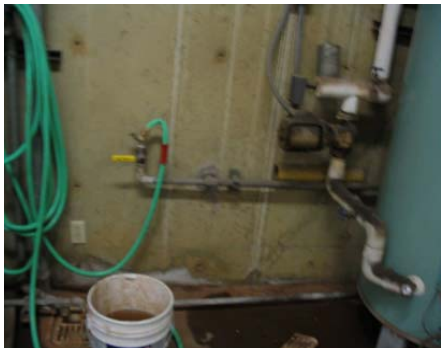
- Level 2330 public toilets, water closets are wall mounted flush valve with new Geberit automatic flush valves. Units are in fair condition.
- Toilet rooms on level 2350 have floor mounted flush tank water closets.
- Urinals are wall mounted flush valve with new Geberit automatic flush valves. Units are in fair condition.
- Lavatories are wall mounted with newly furnished Geberit automatic faucets. Units are in fair condition.
- Floor drains do not have trap primer; therefore they do not comply with current code.
- Floor sinks in equipment room #227 and #301 do not connect to trap primers, and the room is being used as outside air plenum; therefore they do not comply with the current code.
- Hose bibs in and outside of the building do not have vacuum breakers; therefore they do not comply with current code.

A hose bibb without vacuum breaker

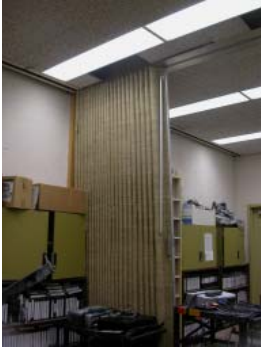
Replace old or worn items such as room divider.

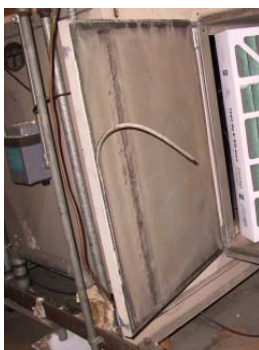
**Figure 3** – Example of door gaskets that need to be replaced.

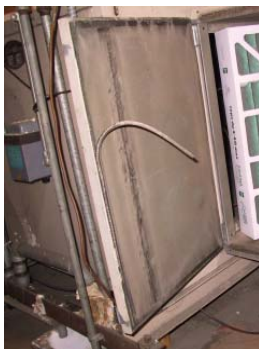
**Figure 3** – Example of door gaskets that need to be replaced.

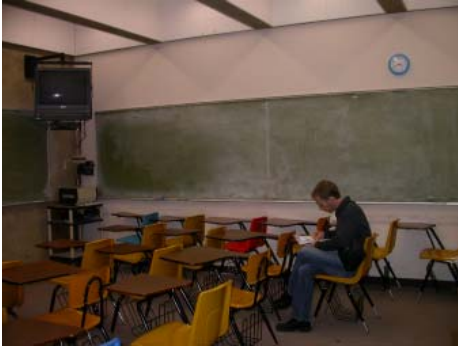
**Lecture 216** - Typical classroom.
